TO ALL AREA AND LOCAL INSPECTORS AND CLUB SAFETY OFFICERS

NOTIFICATION OF A CAA AIRWORTHINESS DIRECTIVE

CAA AIRWORTHINESS DIRECTIVE 001-10-88

SUBJECT - DESCRIPTION Propeller - Replacement of Attachment Bolts

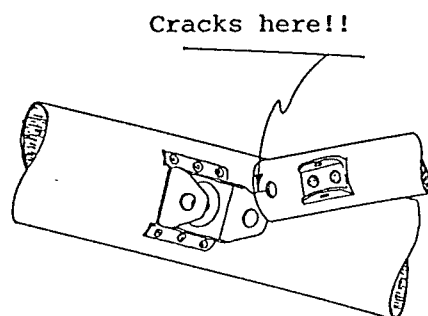
SUBJECT WING TRAILING EDGE ROOT ATTACHMENT

Operational experience has indicated that a problem may occur on the root end of the wing trailing edge tube on some machines. Loads applied in flight can cause a crack to occur on the front face of this tube between the root and the actual fixing hole where the spar is bolted to the fuselage tube bracket.

No evidence suggests that the inner sleeve is also cracking and thus there is no suggestion of a potential catastrophe; the rear side of the tube is not suffering in the same way. However it is ESSENTIAL that the aircraft is checked immediately before further flight.

Examine the tube closely, at least with an inspection glass, with the wing disconnected from the fuselage bracket. Check for any sign of a crack at the point indicated. If there is a crack, do not fly until the item is fixed. Enter the check in your aircraft log book. IF IN DOUBT get your inspector to check this for you.

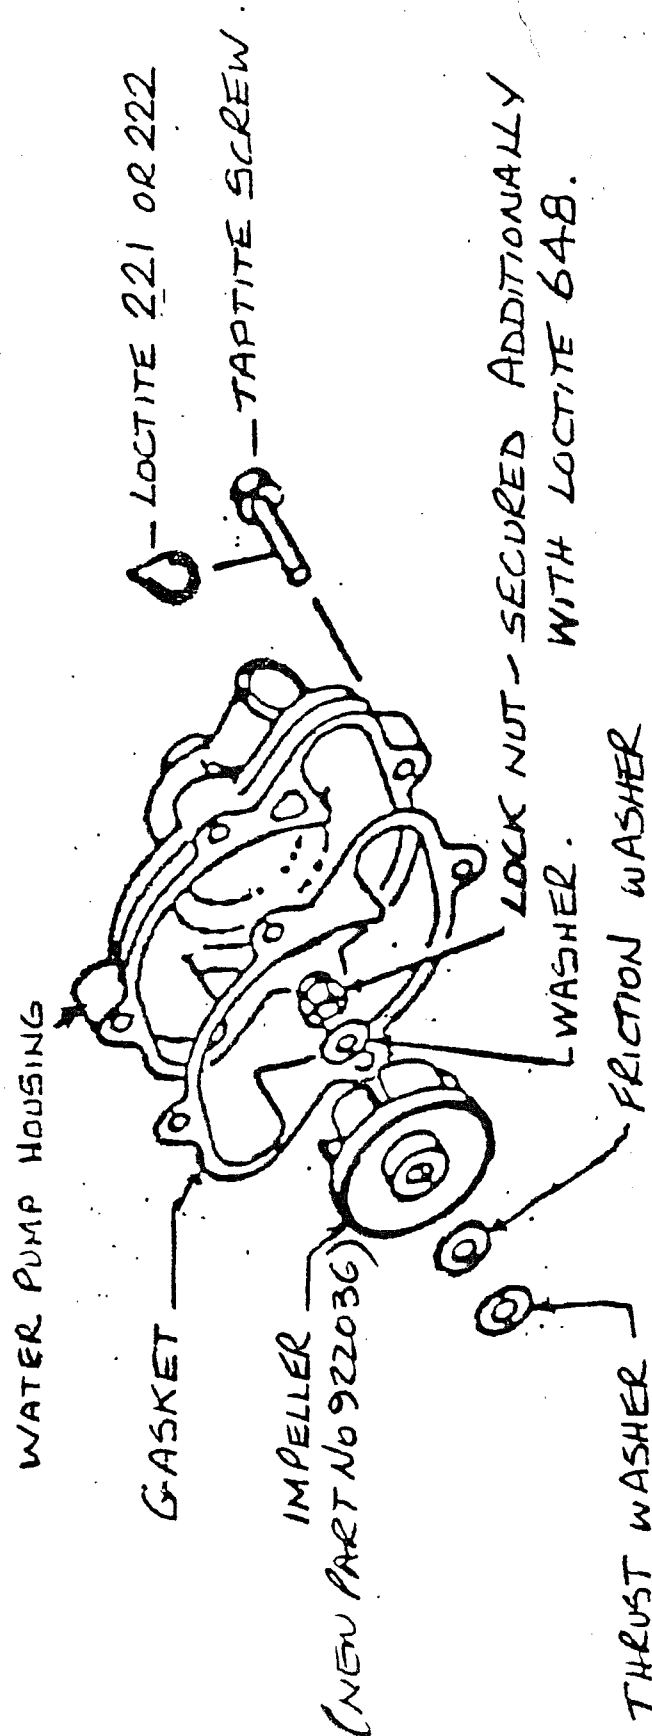
"Some cases have been reported of failure of the plastic water-pump impellor on recent liquid-cooled engines. The problem has been isolated to heating of the impellor-shaft, due to additional friction of a recently introduced sealing-system. In some cases, this has caused the plastic impellor to soften and lose its drive, which is through a toothed or serrated friction-washer and a flat on the shaft. The consequence of such a failure is a fairly rapid over-heating of the engine. Engine failure and, possibly, severe engine-damage will result if the over-heating is not detected quickly and the engine power reduced to idle.

Impellor replacement procedure; dismantling. (See illustration overleaf).

Remove water-pump housing by loosening four Taptite screws.

Place thrust washer, followed by toothed friction-washer, on shaft, teeth (serrations) towards impellor. Slide impellor on shaft, followed by washer. Apply Loktite 648 to thread on shaft. Fit lock-nut. Torque to 8-10 Nm (6-7.5 lb.ft) Replace gasket if necessary. Refit housing with four Taptite screws, after applying Likhtite 221 or 222 to threads. Torque to 5 - 6 Nm (3.8 - 4.4 lb.ft). Replace hose and refill system with water.

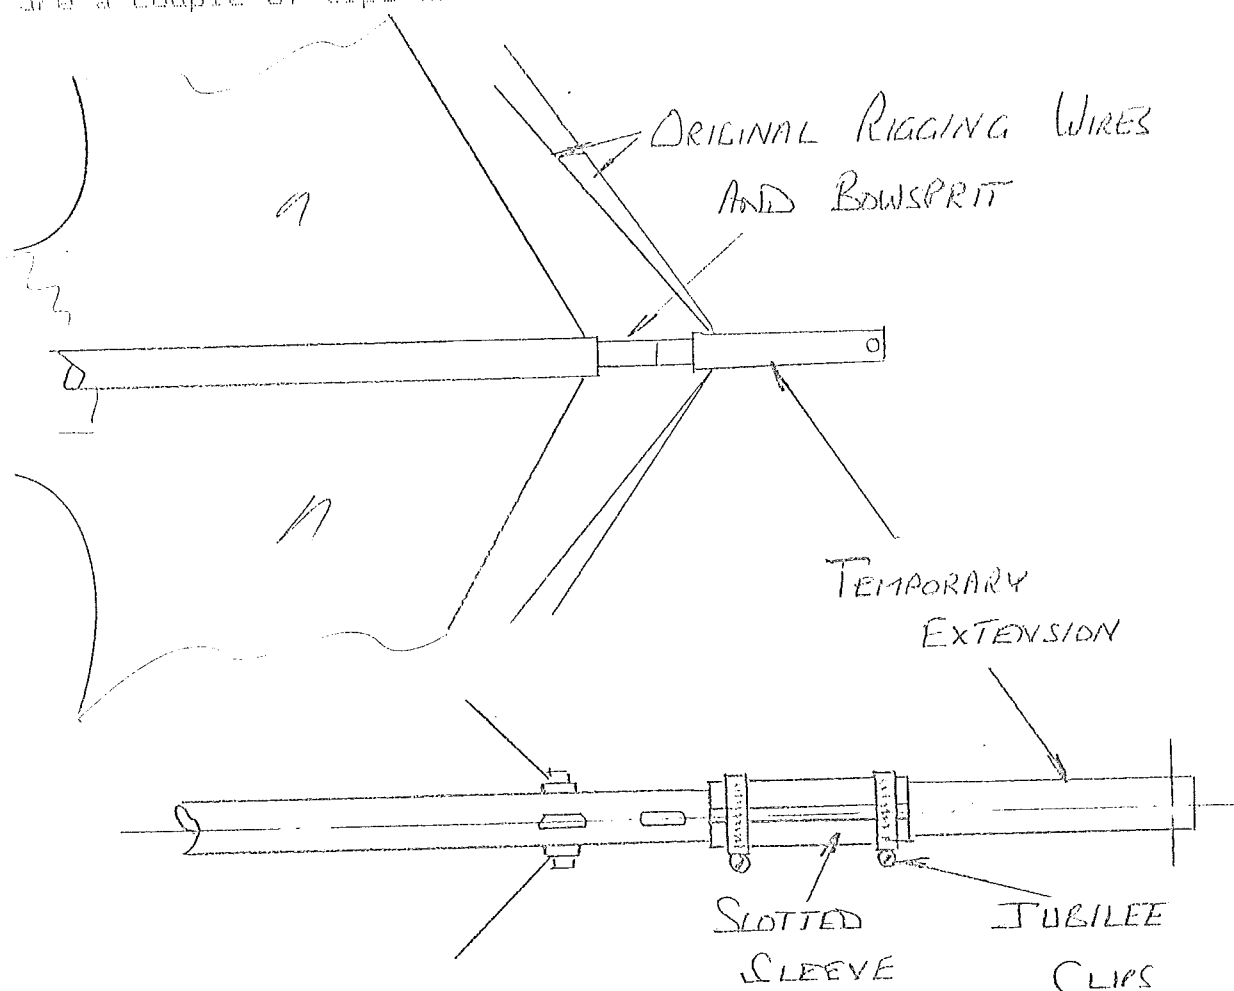
"Regarding the problems experienced by Clifford Sims after doing the modifications, it is very important to establish the pre-modification geometry of these wings before disturbing them. Here are a couple of tips which I have used.

With the wing rigged, fit the temporary extension and establish the dimensions of the new bowsprit by adjusting the sleeve.

Now measure the length of the new outboard bowsprit wires to the leading edges. Measure very accurately!

Next, fit the new bowsprit and wires. The wing sail-tension should be the same as in the pre-modification state.

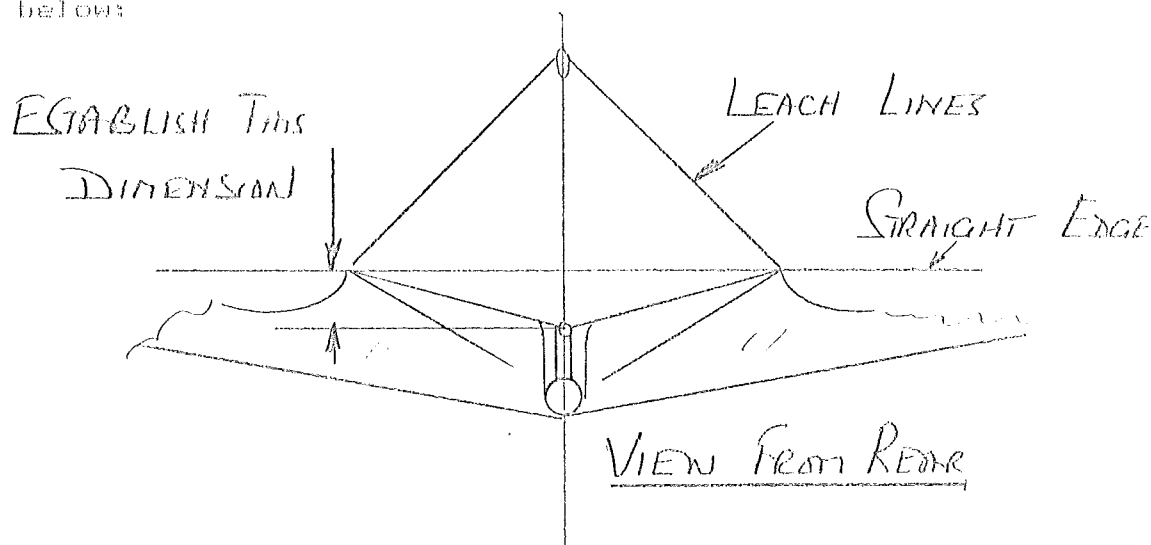
Before disturbing the top rigging, check the leach-line setting as below:

Reset the leach-lines very slightly higher (1/4 inch) than in the pre-modification state, to correct for the new bowsprit weight.

Note, if the outboard bowsprit rigging wires are very tight, giving an equally tight sail, the roll response and stability could be seriously affected, as well as the pitch."
