PEGASUS WINGS & QUIK RANGE OF WINGS

WING – General

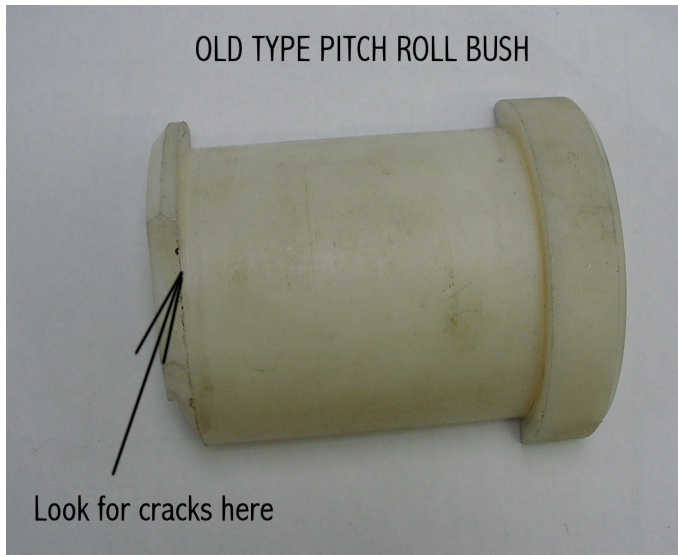
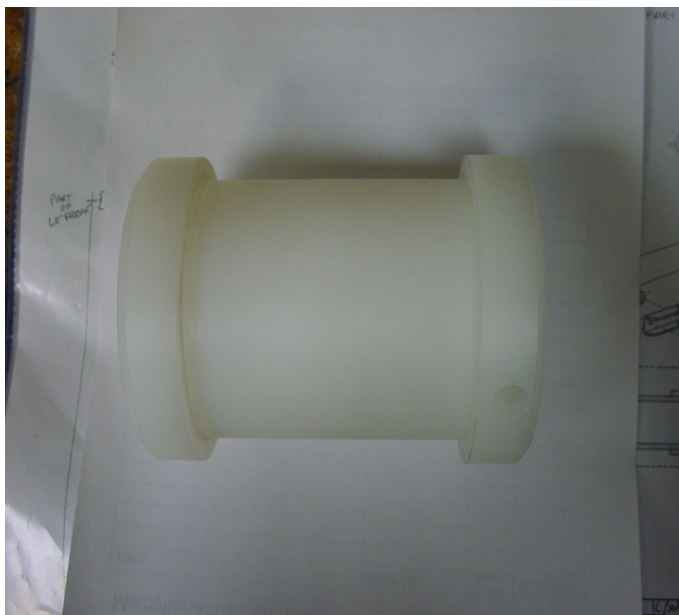
1. Roll Bush

The original tolerance in the roll bush was increased to stop roll stiffness if the bush should swell. Following the tolerance change a few roll bush flanges were found to have cracked and/or broken away. The flange length was therefore increased as shown in the photo below. On early wings check carefully for cracking.

Later wings use a new material for the roll bearing, a dark grey material called Vesconite, which is non-hygroscopic and hence non-swelling.

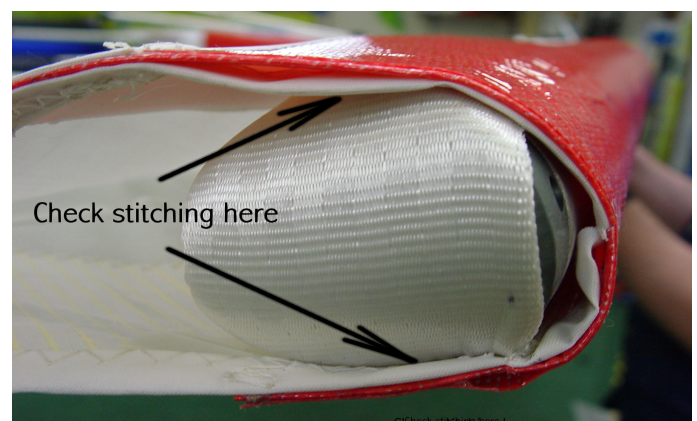
6. Tip webbing and UV cover

It is vital that all wings have had service bulletin 84 carried out. Where the tip modification has not been carried out the UV/abrasion protection patch must be glued properly in place and no broken stitches holding

the tip webbing in place can be accepted. By now all Q2 wings should have the later type tip webbing stitching done, identifiable by multiple V rows of stitching as opposed to the original style which was a simple rectangle with two diagonal rows of stitching.

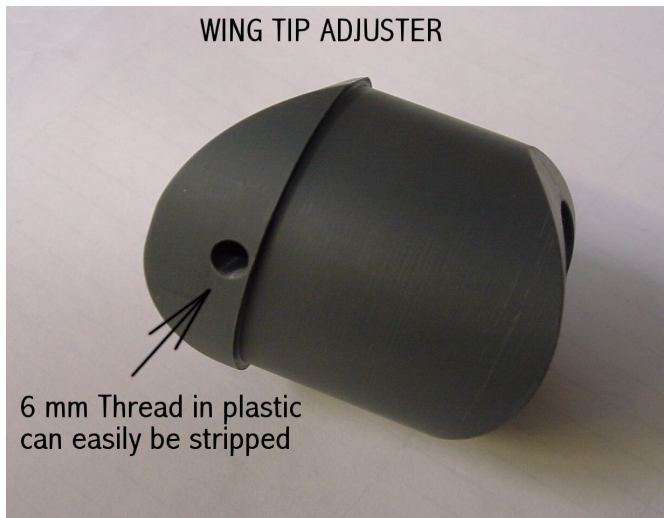
8. Stripped Thread in Tip Adjuster

Owners have been known to over tighten the socket head screw in the tip adjusters, check that the screw is present and tight. Note NO washer should be fitted here, the tip adjustment depends on the socket head screw biting directly into the leading edge.

An optional modification is available to attach tabs to the mylar leading edges, secured by a dome head socket screw to the tip adjuster, which must be tapped M8. (Modification M125). This stops the mylar wrinkling and migrating towards the nose.

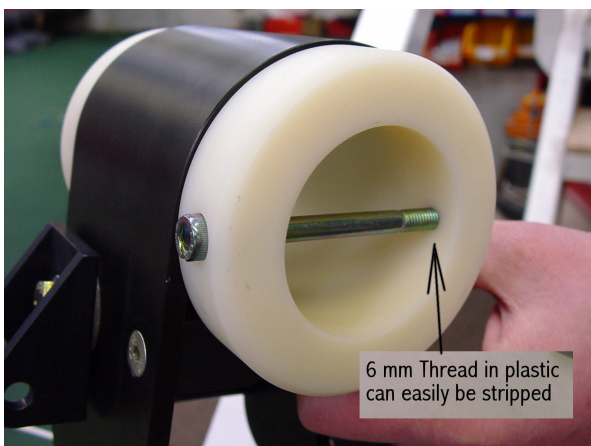
9. Roll Bush Retaining Bolt Stripped Thread.

Check socket screw for tightness and stripped threads. Do not over tighten, as the tube will be distorted causing the roll bearing to become stiff.

There is a modification recommended for this area introduced on the GT450, to use a longer bolt where the shear loaded part of the bolt is on the plain shank and where the roll bearing is recessed to accept a nyloc nut.

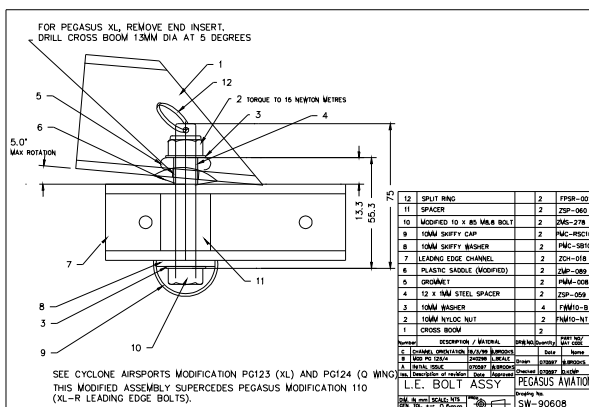
13. Crossboom To Leading Edge Channel Bolt and Bush.

The main bolt connecting the end of the crossboom to the leading edge channel was originally 5/16". Modification PG124, necessary for operation at 409kg AUW, was introduced in 1997 to increase the size to 10mm diameter, M8.8 material. It is provided with a bush, rocking saddle and rubber grommet allowing the crossboom to float up and down at the keel, without bending the 10mm bolt. The 10mm bolt should be torqued to 15NM and a safety ring installed above the nyloc nut.

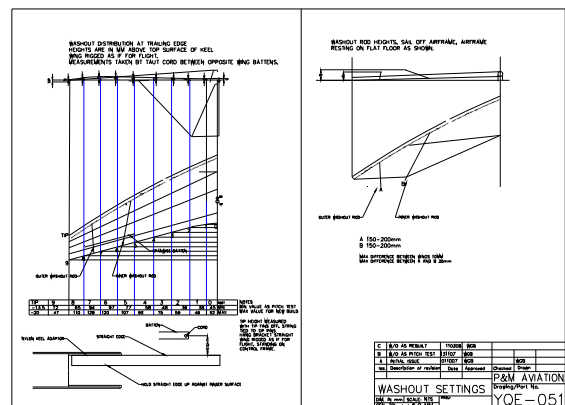
Washout Distribution

Note that the washout distribution in the wing is critical for pitch stability and MUST conform to drawing YQE-051, also shown in the operator's manual. The wing should be supported rigged as if for flight, with the hang bracket straight, with the keel approximately level and supported at the back (we use a cord attached to the ceiling for this).

The inner washout rod is essentially fixed. If the washout is wrong, remove the inner washout rod and ensure it is bent to the batten plan. On reassembly, ensure the cable stop is not damaged and check it engages properly in the bolt at the end of the washout rod.

The outer washout rod is adjustable. Detach the M5 bolt securing the washout rod cord, cable and bungee. It may help at this stage to have an assistant with a rod pushed in through the wingtip to keep the bungee under tension. Rotate the rod clockwise to drop the rod and vice versa. 1 turn is approximately 6mm at the trailing edge.
