QUIK RANGE & QUANTUM TRIKE – INSPECTION AREAS

These problem areas are not intended to be all-inclusive, but to highlight specific problems that have been found on the Quik and Quantum range of trikes. Normal wear points common to most aircraft have not been covered in this document. It is intended as a guide only and must be used in conjunction with normal BMAA inspector practices.

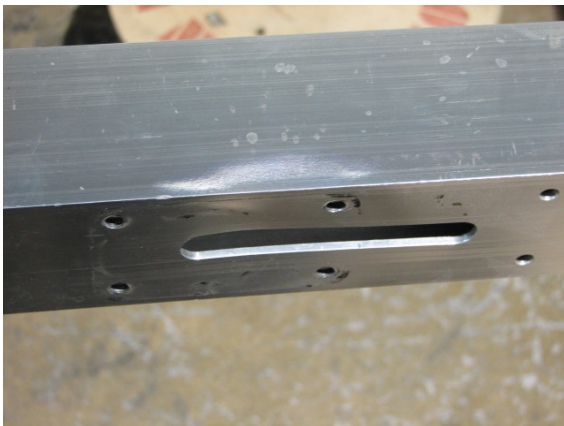
2. Dents In Keel

If a nose wheel has been subject to excessive loads, the underside of the keel can be dented at steering head. Check and if found the front steering needs dismantling to check all components, particularly the trailing link. (see below) The steering head plates also need checking to ensure that they are flat. The front fork legs should also be checked to ensure that they are straight.

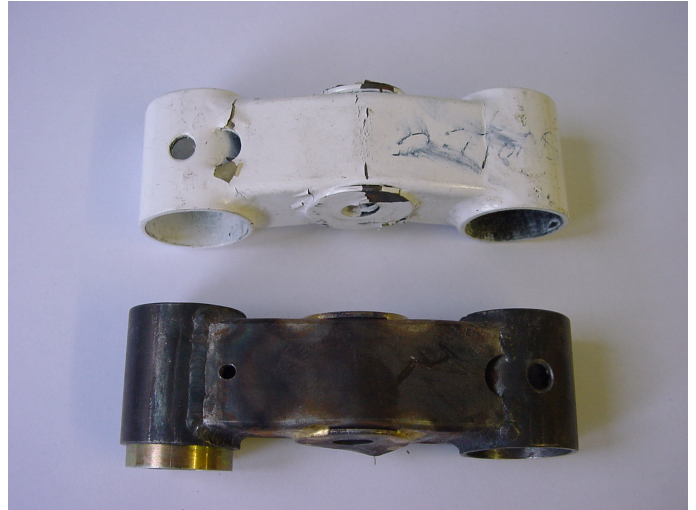
3. Trailing Links.

Early trailing links had the bushes bronze welded in place. Following a couple of failures on gross overloading (see bulletin 85, the design was changed to make the drain hole smaller and the bushes welded in place. A recall should have dealt with all aircraft by replacement, but check for any that slipped through the net. The picture shows both early and modified links after load test.

(Lower Link Correct Style – Note drain hole position.)

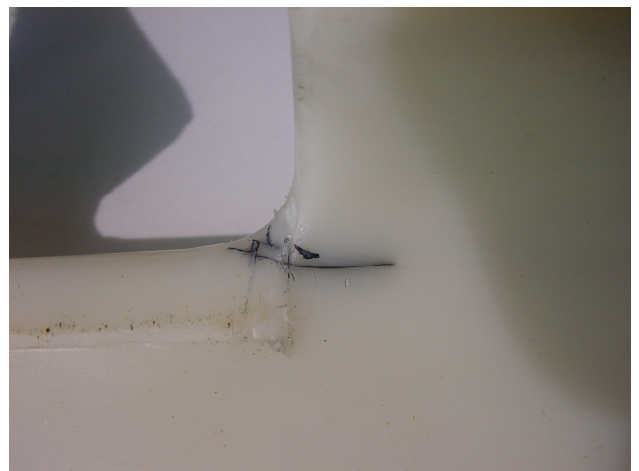
6. Fuel Tank Leaks

A batch of fuel tanks were prone to leaks, see service bulletin 100 for remedial action and ensure owners have fitted the straps on effected trikes.

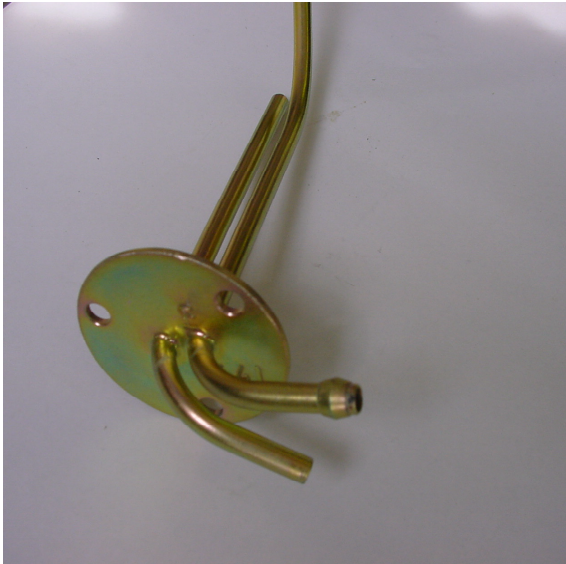
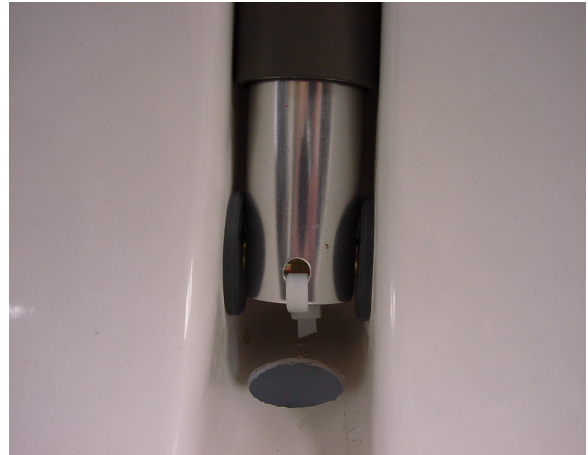
7. Fuel Pickup Pipes

There is now no reason why the fuel pick up pipes should limit the amount of fuel. If the fuel tank cannot be filled then check to see what the pick up says, and if necessary trim the breather pipe back to allow filling of the fuel tank. A cockpit load Vs weight placard will also need adding to the dash with the new figures.

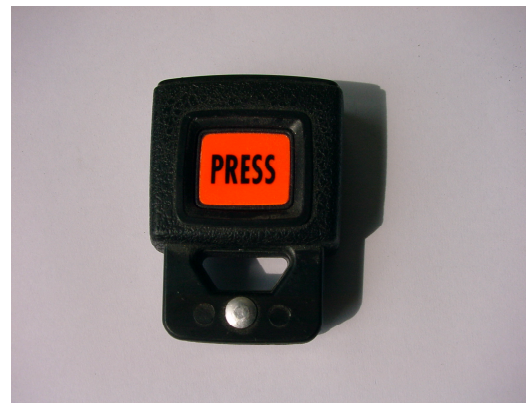
9. Seat Harness Latches

On a batch of seat belt latches it was found that when under tension the harness latch could not be released. Check the release while pulling on the belt, replace if fault found.

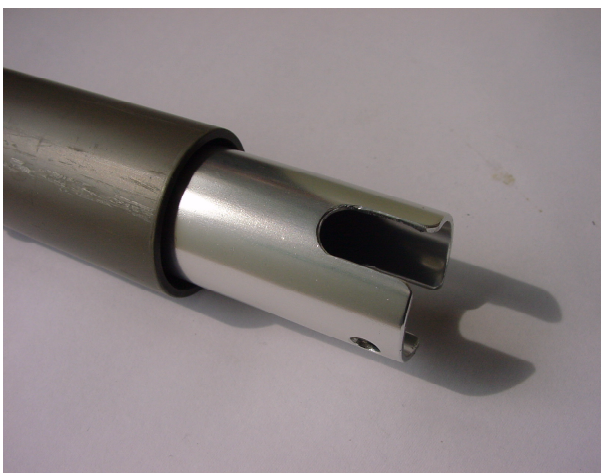
8. Seat Back Tube

The lower end of the pilot's seat back is a tube with a slot located over a bolt and secured by a tie wrap. This arrangement allows the seat to break loose in an accident thus protecting the passenger from upper leg and groin injury. The slot may open up producing cracks, particularly on early models with longer slots.

Later seat back tubes have an additional insert to help prevent cracking.

The seat back should also be checked for security on the tube.

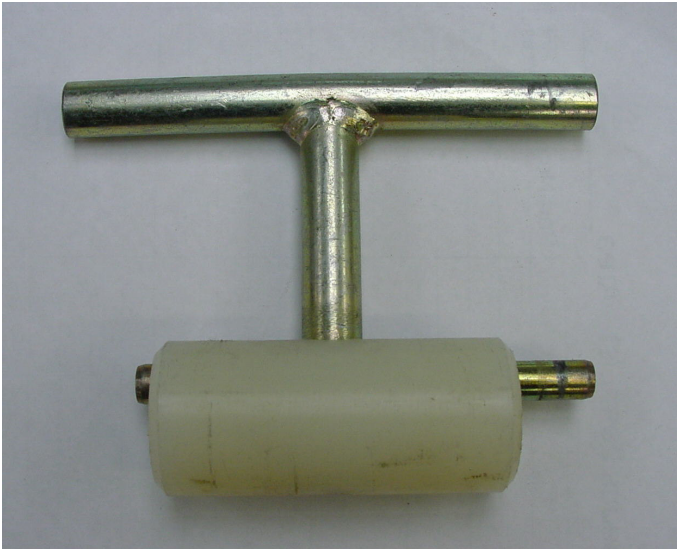
11. Pylon Over Centre Catch

The catch pin is glued into the nylon, a few cases of the pin drifting out of position were found. On later versions the pin was ground away in the centre to provide a key for the glue.

With the introduction of the Quik, this pin was replaced with an AN5 bolt and nut, which further helps prevent the pylon guide opening up in the event of an accident.

The Overcentre Catch Guard was also removed, so not always present on aircraft.

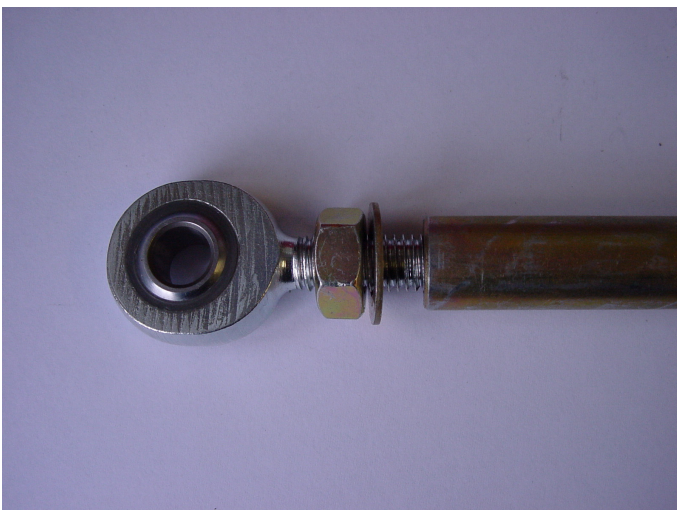
12. Undercarriage Leg

The Quantum undercarriage leg suspension shock absorber assembly is held together by a nut locking the rose joint thread into place in the shaft. Although the nut is visible, the thread in the shaft inside the leg tube is not. We have known of 3 cases where the

thread completely came away and the undercarriage leg came apart. The rose joint nut security can be inspected by rotating each undercarriage leg, the rotation should be limited to the play in the rose joint bearing. If the leg rotates without the bearing, then the leg must be dismantled and service bulletin 82 carried out. It is absolutely essential that the service bulletin action has been completed, so check that it is logged.

Note that aerofoil side struts have a different method of assembly which eliminates this problem.

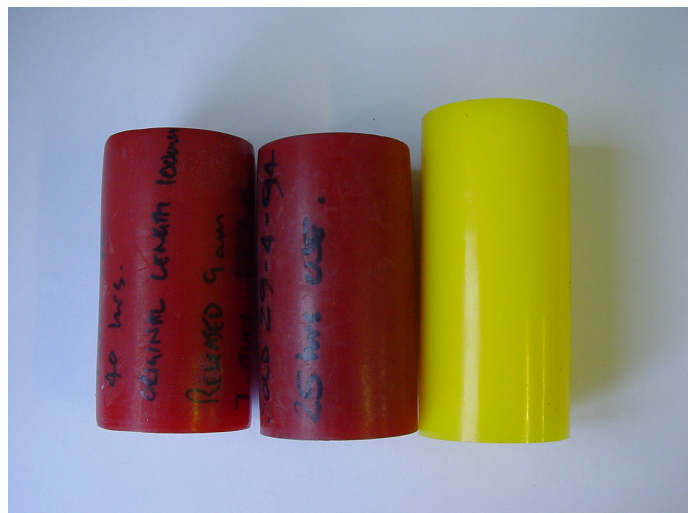
14. Suspension Shock Absorbers

A batch of shock absorbers was cured with the wrong process. Consequently when compressed they did not return to full length. Check for free play in the shock absorber at the top of the undercarriage legs. The photo shows bad specimens against a good one.

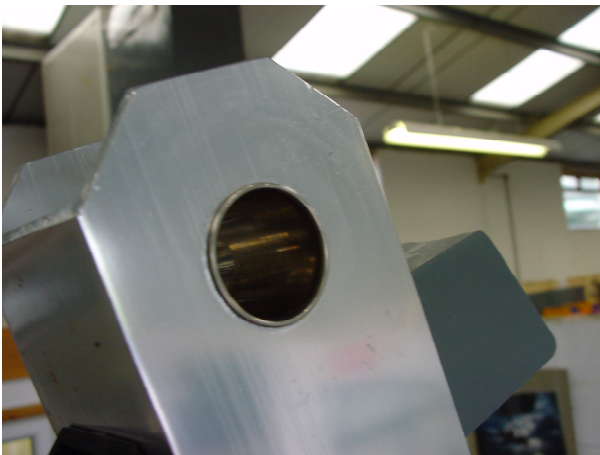
17. Hang Bracket Pitch Bush

A stainless steel bush is peened into pylon for the nylon pitch bushes to run in. Glue is used to fit the two halves of the nylon pitch bush and occasionally we have come across excessive glue having glued the nylon bushes to the stainless bush. As a consequence the stainless bush has been forced to turn and wear the pylon. Check the peening and that the stainless bush is tight in the pylon. Service Bulletin 117 details this and also introduces a modification to help cure the problem.

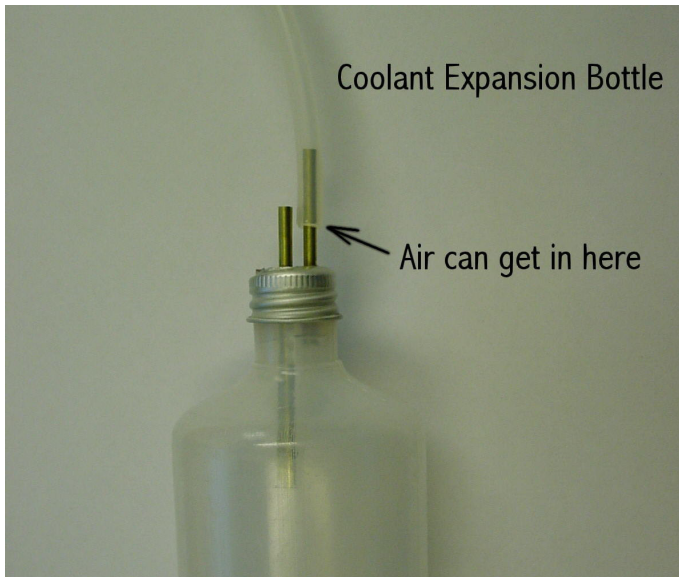
26. Coolant Overflow Bottle

Early coolant overflow bottles had the overflow pipe attached to a brass tube as shown in the picture. It was possible that the air seal was not good and the resulting leak prevented the coolant from being sucked back into the system on cooling. Later versions had no brass tube with the pipe going directly to the bottom of the bottle.

Newer aircraft now have a different style of overflow bottle fitted to the gearbox. Check the pipes for kinking with this design.
