BMAA Inspectorate Notice: ISSUE 2 - Rotax Sinking Carburettor Floats

UPDATED: 24/06/2016

912 Sinking Floats by Adrian Jones

SB-912-065 (UL) / SB-914-046 (UL), October 06, 2014

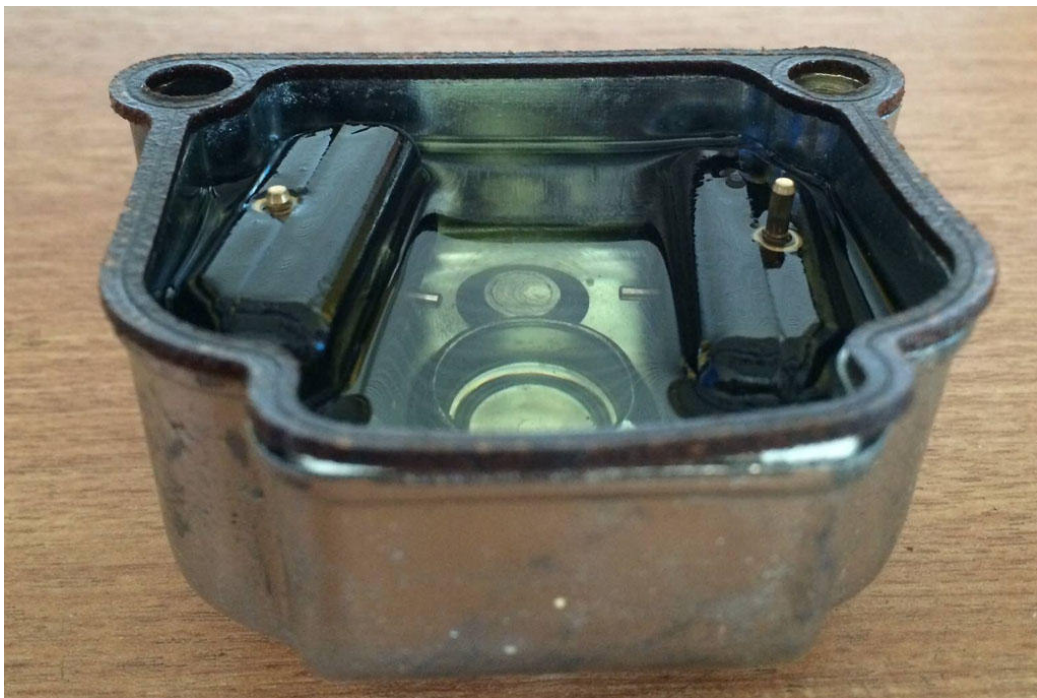
It sounds to us like a materials problem. The floats are made from closed cell foam which should not absorb fuel. However, we have had a report from a BMAA member who cut open an affected float, to find that it had indeed absorbed fuel. It looked like the fuel had diffused through the cell walls.

Now you might expect the inspection procedure to be a straight forward removal the float bowl and a visual check that the floats are floating at the right level. Simple! The picture below shows the LH float at the correct level, with the side pin just about at the surface, and the RH one too low.

It is therefore highly recommended to undertake regular checks as per the Rotax Bulletin SB-912-065 R3, which states the floats should be inspected every 25hrs. It is also recommend to consider inspecting the floats, before any flight when the engine has not been run in the preceding 30 days, or more.

Now before you lose the will to live let me quickly say that Skydrive have ridden to the rescue and agreed with Rotax that they can recommend a simpler inspection procedure for non-certified engines, where the carburettor bowls are easily accessible. We have published their guidance on our website under BMAA Technical Office / Inspector Zone / Notices and Alerts.
