BMAA Defect Alert #0054 - Red Aviation SB030 - Neuform Propeller Hub Cracking

SB030 – Neuform Propeller Hub Cracking

Service Bulletin – SB 30 Issue 1

Applicability – Ikarus C42 fitted with Neuform Propeller

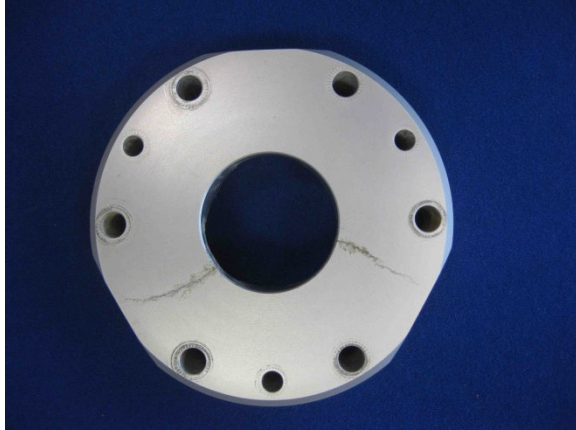
Picture 1

We have been made aware of cracks starting from the centre hole in the hub on some Neuform propellers.

As can be seen from the pictures 1 to 3 below, the cracking is quite extensive and the two principal cracks have gone nearly the complete radius of the outer hub. Some cracking was starting in the inner hub (not shown) but this was not so extensive. From the corrosion around these cracks it appears that they have been there for some time. On picture 4 however, the crack is much less noticeable and not really visible with a naked eye, so crack detection fluid has been used to highlight the crack.

We recommend that before your next flight you remove the spinner and take a very close look at the front part of the hub assembly for any sign of cracking. If there is any doubt we suggest the use of crack detection fluid.

If any cracks are found **DO NOT FLY** the aircraft.
