# **SERVICE BULLETIN**

## **Owner's Service Bulletin – OSB 31 Issue 1.0**

**Applicability – Ikarus C42A & B models with A-strut passing through main fuselage tube**

### **Inspection of inside of A-strut for cracking**

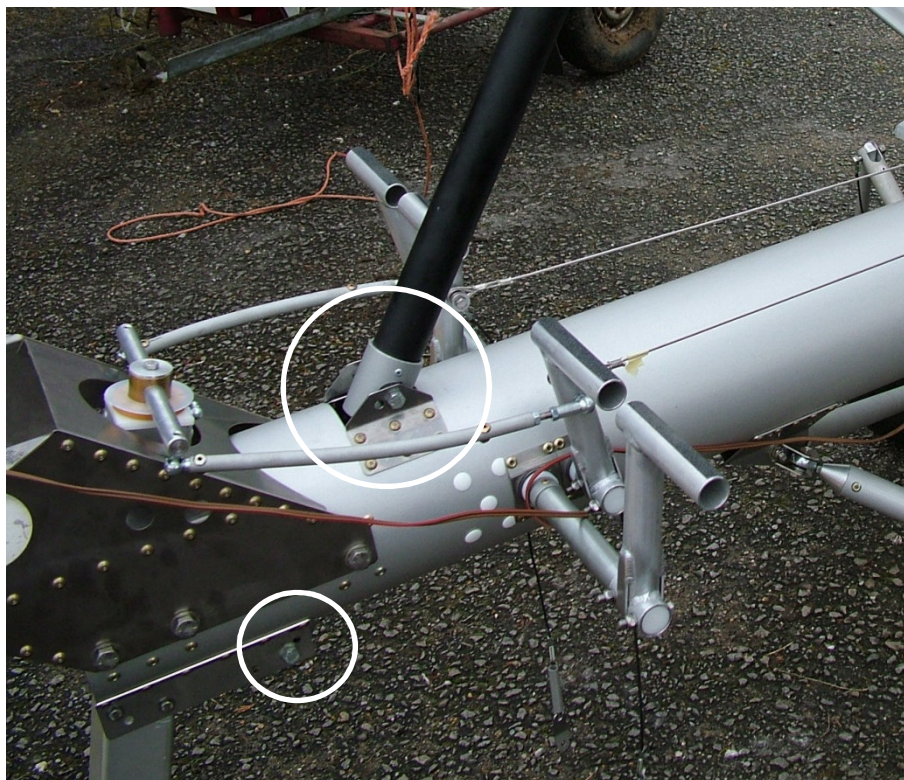
An aircraft with severe cracking of the main fuselage tube emanating from the upper cut-out for the A-strut was also found to have suffered severe cracking of the A-strut around its entire circumference. This was hidden within the outer sleeve positioned at the connection between the A-strut and the upper surface of the main fuselage tube. The load path was maintained by the single small rivet used to locate the outer sleeve on the A-strut. See Figures 1 & 2.

**Figure 1; A-strut attachment to upper surface of main fuselage tube. Lower attachment bolt visible beneath main fuselage tube at aft end of bracket attached to nose leg.**

We recommend that before next flight the internal surface of the A-strut in the region of the bolt passing through it at the connection to the upper surface of the main fuselage tube is visually inspected for cracks, using a borescope inserted from the lower end.

We recommend that at the next annual or 100hr inspection, whichever comes first, the internal surface of the A-strut in the region of the bolt passing through it at the connection to the upper surface of the main fuselage tube is visually inspected for cracks, using a borescope inserted from the lower end.

If any cracks are found **DO NOT FLY** the aircraft. Please contact [malcolm@red-aviation.com](mailto:malcolm@red-aviation.com) for instructions for fitment of a replacement A-strut.

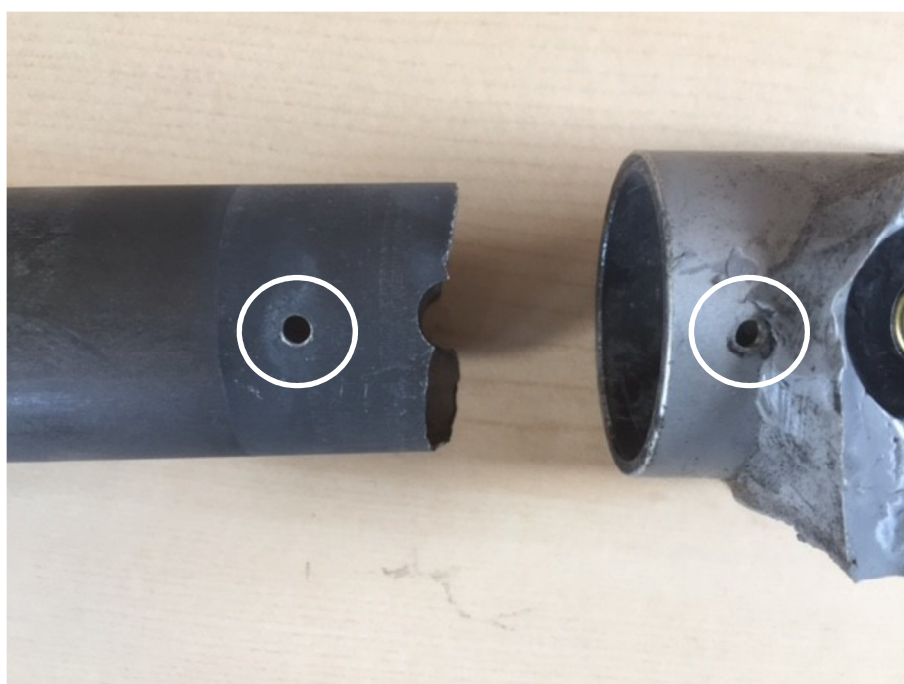
It is believed that the cracking was a result of excessive loads placed upon the A-strut due to the near-failure of the main fuselage tube. One other similar historical case is known to have occurred abroad, on an aircraft known to have suffered landing gear damage.

**Figure 2; Failed A-strut removed from outer sleeve part on right of picture. Circled holes show location of the rivet which was holding the parts together.**
