**BMAA Defect Alert #0068:** P&M Aviation Ltd SB147 - Rigging cables with roll swaged end terminals

**Rigging Cables with Roll Swaged End Terminals – Inspection / Replacement**

# **SERVICE BULLETIN NUMBER 147, issue 2.**

| <b>TITLE</b> | Rigging cables with roll-swaged end terminals. |

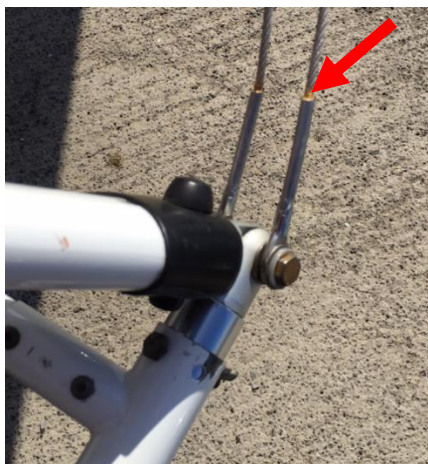
A P&M GT450 in a flying school had a partial failure of a lower side rigging cable (Part No. YQD-045) when recovering from a spiral manoeuvre, within the limits of the flight envelope. These cables are arranged in pairs, to give a backup load path. The second cable carried the load and the aircraft landed safely. This is the only P&M production lower side cable failure we have been aware of since 1984. See fig 1. for cable definitions. The partial failure was at the edge of the roll-swaged terminal end shown in fig 2. The alternative cable terminations using Nicopress sleeves and thimbles allow more progressive flexing of the cable. See fig 3.

Fig 2. Overall general arrangement of the GT450 lower side rigging cables with roll-swaged terminal ends. The arrow shows the point of partial failure. The attachment bolt at the control frame knuckle should be just loose enough to allow each cable to align with the load. Note the plating on the bolt head is shiny in this example.

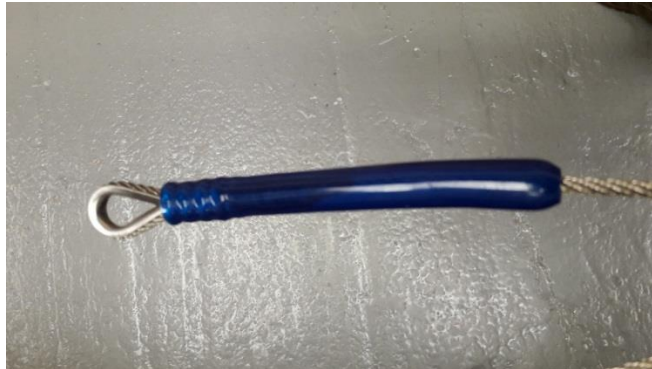
Fig 3. A thimble and Nicopress sleeve type fitting. The blue plastic shroud can be pulled back for inspection of the sleeve.

Replacement GT450 lower side rigging cables are now being provided as a kit featuring thimble and sleeve type ends and a longer control frame knuckle bolt (minor modification M313). Note - for cables with thimble and Nicopress sleeve type ends, replacement at 800 hours/7 years is recommended *but not mandatory*, provided detailed inspection is carried out at each permit revalidation.

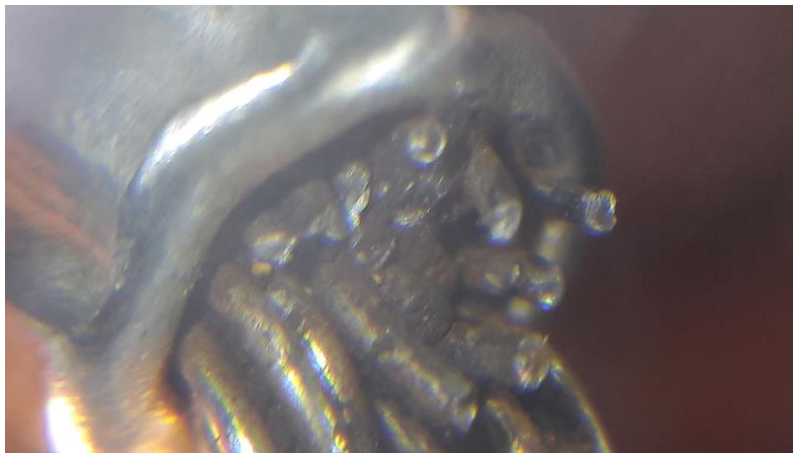
The incident GT450 lower side rigging cables had been in use for 1050 hours and 9 years. The aircraft had been subject to an accident and rebuilt once in its life. It was also operated quite near the coast where it has been considered that sea air Chlorides could have affected the material. There were corrosion pits in the S316 stainless steel material which accelerate fatigue failures. CLSCC (Chloride Stress Corrosion Cracking) is known to affect stainless steel.

The cable fitting was at the bottom end of the cable, where solutions can wick down it and collect. The strand failures were caused by bending and tensile fatigue because of cracks propagating from scratches and corrosion pits on the surface. See figs 4 & 5.

All the remaining cables had broken strands at the edge of the roll-swaged terminals. Some of these strands had been failed for some time, as shown by discolouration of the failure surfaces. The cable is 7 cores of 7 strands construction.

The central core, being straight, can pick up more tensile load than the others and can fail before the outer ones. The broken strands are hard to spot, especially in the inner core of the cable and so it has been considered necessary to put a replacement life on structural cables with roll-swaged terminals.

Fig 4. Magnification of edge of the roll-swaged terminal of the partially failed cable. Note dirty surfaces of old failures and corrosion marks especially in the central area, which is hard to inspect externally. Several strands had been broken for some time before the failure.

For applicable cables with more than 800 flying hours or 7 years of service, whichever comes first, before further flight, visually inspect at the edge of the roll-swaged terminal(s) using a magnifying glass with a power of at least 3x. Inspect closely for damage i.e. broken strands, corrosion, mechanical damage or slippage. If any damage is found, replace the affected cable before further flight. If no damage is found, replace the cable within 25 flying hours.

All lower side, lower front and lower rear rigging cables with roll-swaged terminal ends must be replaced within 800 hours operation or 7 years age, whichever comes first.

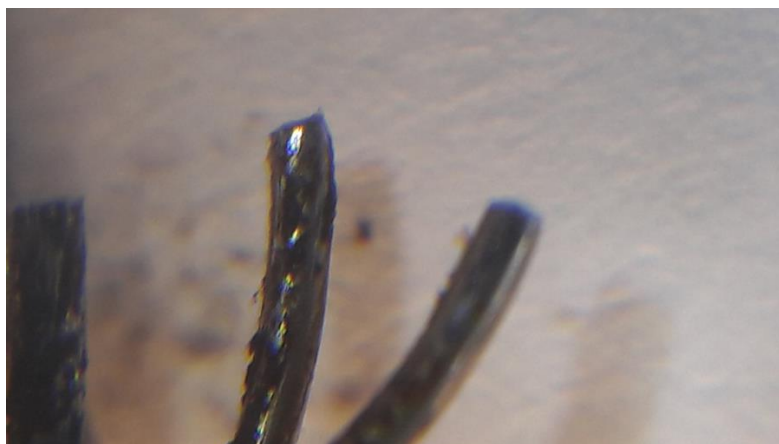
Fig 5. Failed cable strands showing wear grooves and corrosion pits.

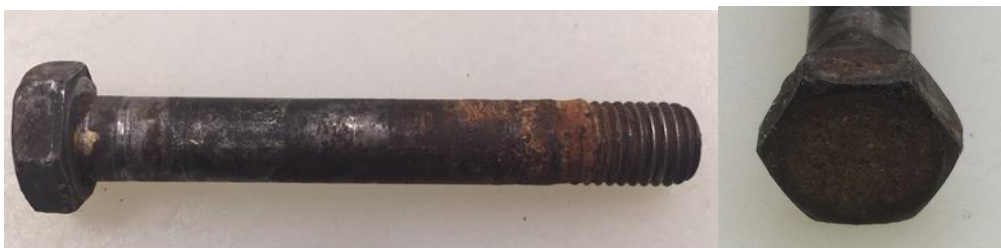
Fig 6. The corroded bolt (Part No. FBA5-21A) that held the partially failed side cable to the control frame.

As can be seen from Fig 6, this bolt displays clear evidence of corrosion and pitting. This is indicative of the general environment in which the aircraft has been operated. This also MAY be indicative of the probability of corrosion occurring within the cable itself. The corrosion on the bolt head is not uncommon for such fittings that are exposed to a salty atmosphere over a long period of time. A clean and bright bolt may well indicate corrosion of the cable is less likely to be an issue.
