**BMAA Defect Alert #0069: Rotax 912 Series - Inspection and/or replacement of the valve push-rod assembly**

**Applicability:** Rotax 912UL, 912ULS, 914UL & 912 iS Sport

# Inspection and/or replacement of the valve push-rod assy., rocker arm left and rocker arm right for ROTAX® Engine Type 912 i, 912 and 914 (Series)

ATA System: 72-30-00 Cylinder head

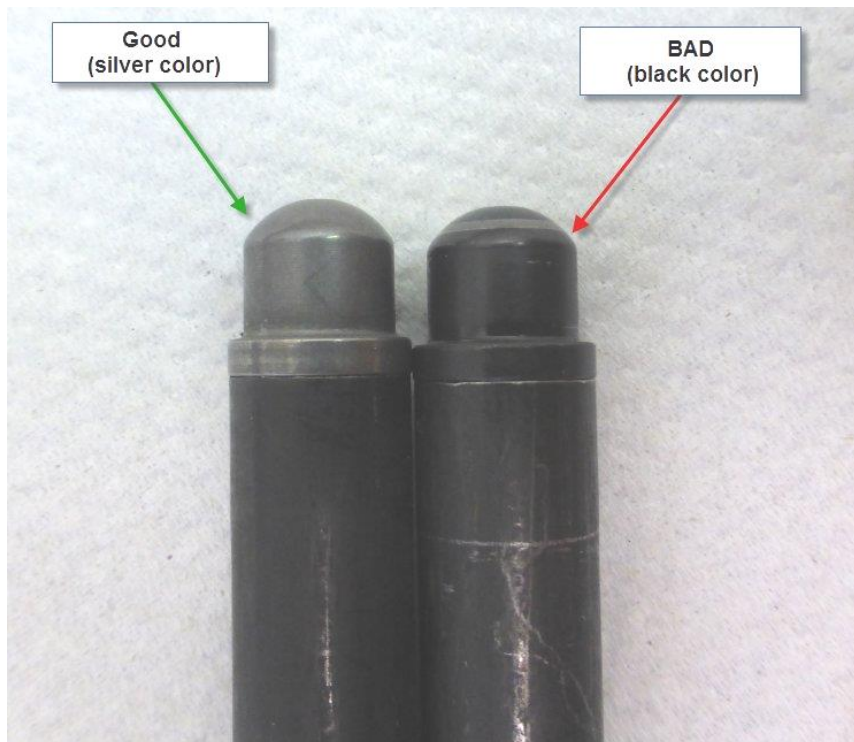
Fig. 1  
Visual inspection

***Due to deviations in the manufacturing process of the valve push-rod assy., partial wear on the rocker arm ball socket may occur. This wear might lead to a rocker arm cracking / fracture which in consequence may lead to a malfunction of the valve train. Possible effects are rough engine running or an unusual engine operating behaviour.***

Check for color. See Fig. 1.

Color	Evaluation
Silver surface	Valve push-rod is OK. No further action required for this valve push-rod.
Black surface	Valve push-rod is NOT OK. See section. <a href="#">3.1.3) Replacement of affected parts.</a>

### 3.1.3) Replacement of affected parts on affected cylinder positions (only in case visual inspection is NOT passed OK)

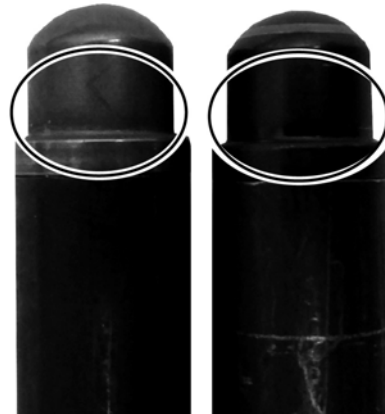
*Fig. 1*  
*Visual inspection*

Perform visual inspection of all push-rod ball sockets on all cylinder.

**GOOD**  
(silver color)

**BAD**  
(black color)

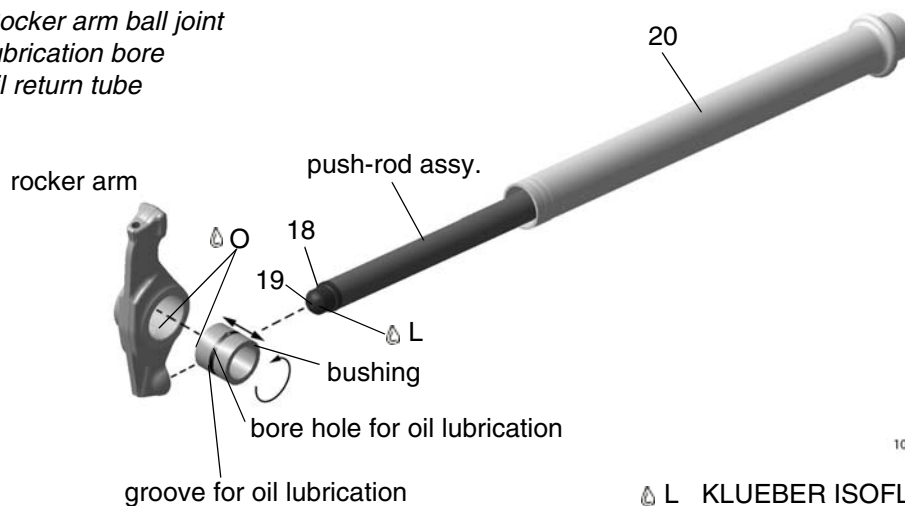
Fig. 3

18 Rocker arm ball joint  
19 Lubrication bore  
20 Oil return tube

Step	Procedure
6	This will relieve the pressure from both hydraulic tappets. Now the rocker arm shaft (9) may be easily pulled out. Lift out both rocker arms (10) and (11).
7	Replace only affected parts as per <a href="#">section 2.3</a> . See also <a href="#">Fig. 3</a> .
8	Apply KLÜBER ISOFLEX TOPAS NB 5051 (16) on both push-rod ball sockets and contact areas of rocker arm and slide push-rod into the oil return tube (20).
9	Check bushing and rocker arm shaft according to latest Maintenance Manual Heavy.
10	Put oil on the rocker arm bushing.
11	Place rocker arm left (10) and rocker arm right (11) in cylinder head, apply KLÜBER ISOFLEX TOPAS NB 5051 (16) on rocker arm shaft (9) and insert it into its bearing support.
12	Loosen valve spring loading jig and support plate.
13	When removing the valve spring loading jig, make sure the adapter rings (15) do not jam on the valve spring retainer.
14	NOTE: Only when you have an Criterion B) Spare parts affected engine and only if engine is equipped with collar cap nuts M8 wrench size 13: Mount collar cap nut (6) according to latest Maintenance Manual Heavy or SI-912-025/SI-914-026/SI-912 i-010.

15	Lubricate all moving parts in the rocker arm space with engine oil or equivalent.
