MICROLIGHT AIRWORTHINESS APPROVAL NOTE

MAAN NO: 1661

TITLE: Microlight Airworthiness Approval Note 1661, ASI and altimeter corrections on Shadow Series C and CD aircraft.

REG: All Shadow Series C and CD

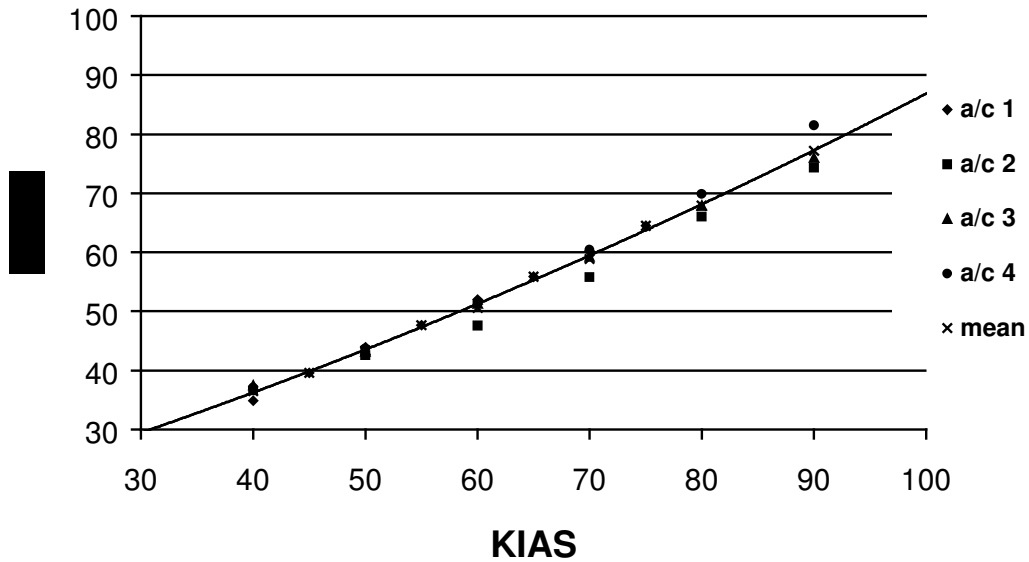
Flights on four representative aircraft have been carried out to gather ASI calibration data for this MAAN.
