MICROLIGHT AIRWORTHINESS APPROVAL NOTE

MAAN NO: 1681

TITLE: Microlight Airworthiness Approval Note 1681, ASI and altimeter corrections on Shadow Series B and BD aircraft.

REG: All Shadow Series B and BD

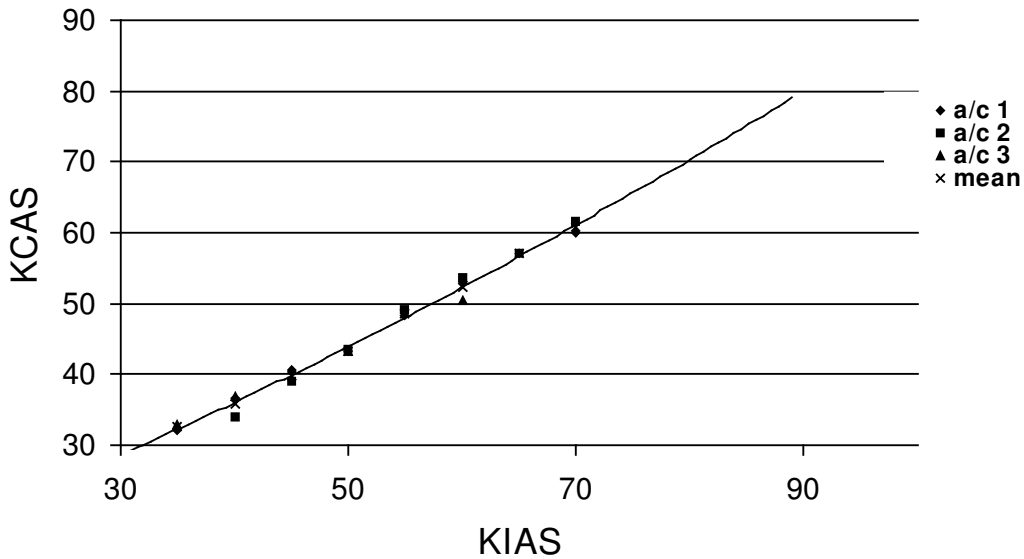
5. FLIGHT TESTING

Flights on three representative aircraft have been carried out to gather ASI calibration data for this MAAN.
