MICROLIGHT AIRWORTHINESS APPROVAL NOTE

MAAN NO: 1682

TITLE: Microlight Airworthiness Approval Note 1682, ASI and altimeter corrections on Type Approved Shadow Series D and DD aircraft.

REG: All Type Approved Shadow Series D and DD

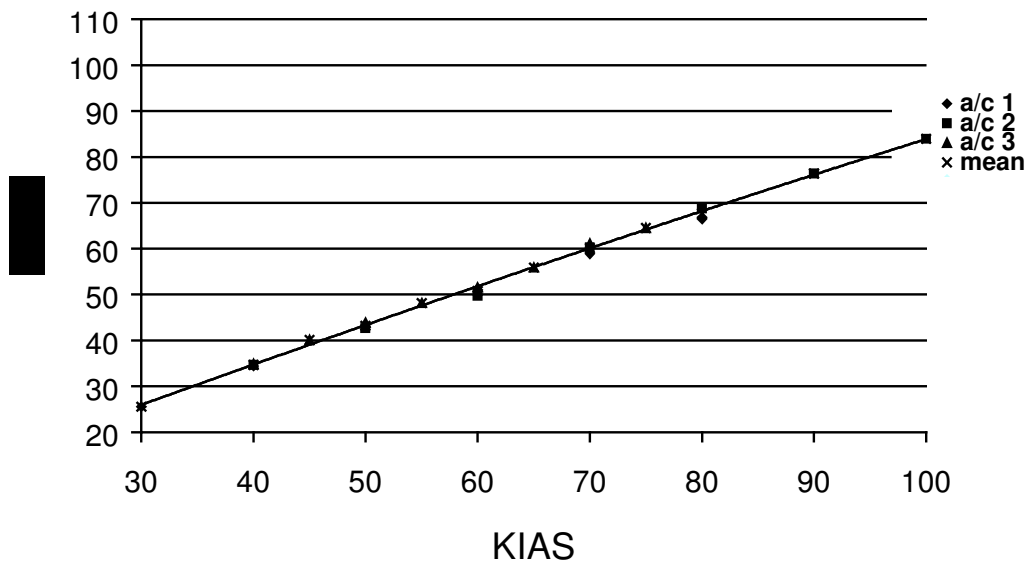
Flights on three representative aircraft have been carried out to gather ASI calibration data for this MAAN.
