MICROLIGHT AIRWORTHINESS APPROVAL NOTE

MAAN NO:1744

TITLE: Microlight Airworthiness Approval Note 1744, Sky Ranger - Service Bulletins 001 and 002.

Applicability: All Sky Ranger aircraft

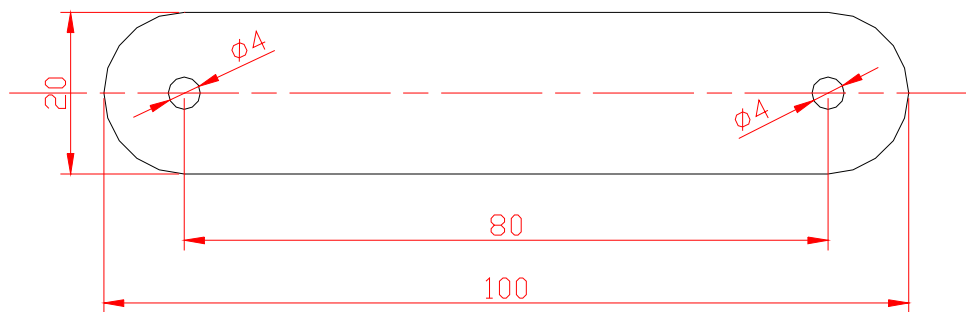
The seat base webbing on some Skyranger aircraft is sufficiently slack to allow the square seat base to deform and slip off the rear supports during periods of negative-g loading. This presents a risk of fouling the port rudder cable which runs under the pilot's seat. To prevent this occurring diagonal braces must be fitted to the seat bases.

Figure 1; diagonal seat brace.

The diagonal braces should be made from 1.5mm thick aluminium sheet or strip, 20mm wide by 100mm long, Figure 1. Two 4mm holes should be drilled in each brace at 80mm centres.

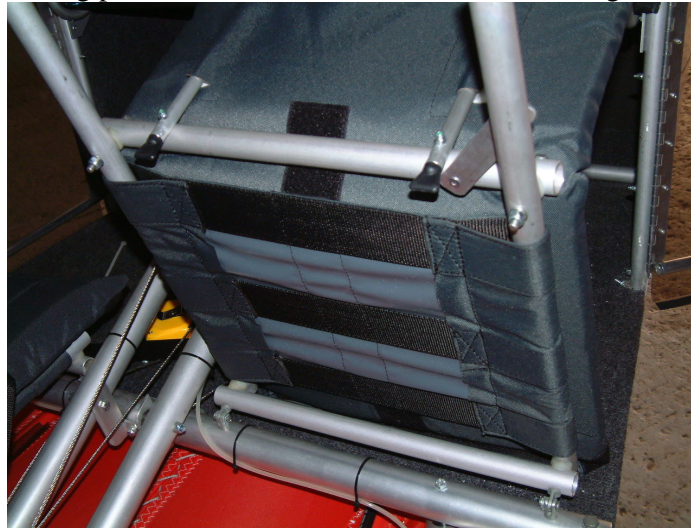
Figure 2; seat base diagonal brace in situ.

A small diagonal bracing piece should be fitted to each seat base, Figure 2.

One brace should be fitted to each seat, between the top surface of the outboard seat base tube and the undersurface of the seat base rear tube as shown in Figure 2. The brace should be at approximately 45° to the two tubes to which it attaches. Mark the position of the brace on the seat base rear tube, and drill and rivet in place with a 4mm steel rivet. Then, with the seat in position on its supports, mark and drill the other hole to accurately hold the correct position, and secure with another 4mm steel rivet.

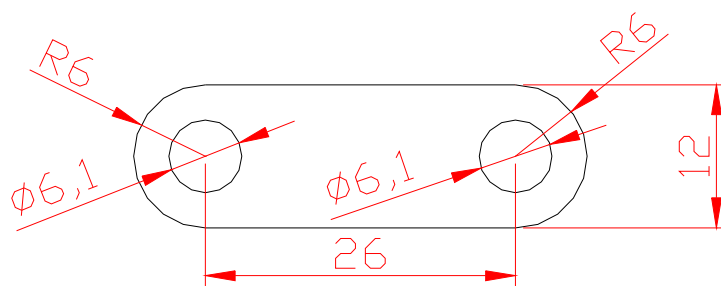
In order to further increase the level of safety when rigging and de-rigging the Skyranger a modification to the aileron cable connections at the control stick has been designed. This makes it difficult to miss-rig the ailerons by handing the cable connections.

Figure 3; stainless steel plates.

Stainless steel plates, 4 off; the plates should be made from 1.5mm thick stainless steel sheet or strip as per Figure 3.

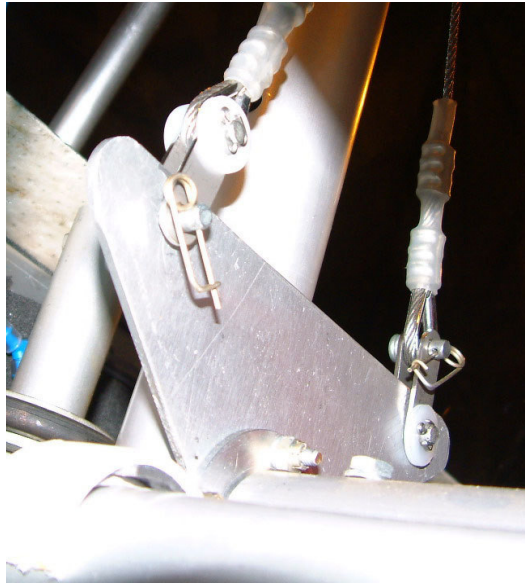
Figure 4; aileron cable connections viewed from beneath.

The existing shackles at the control stick end of the aileron cables should be removed. Retain the shackle pins. Attach a pair of the stainless steel plates to the port aileron cable using a shackle pin and two plastic washers on the outside of the plates to take up some of the slack, and permanently secure with a split pin, Figure 4. Attach the

other pair of stainless steel plates to the starboard side of the aileron horn beneath the dashboard, again using a shackle pin with a pair of plastic washers outside the plates, permanently secured with a split pin.

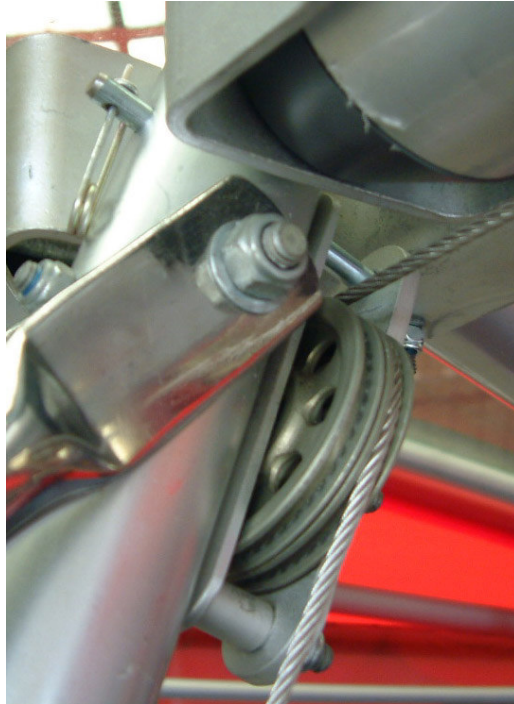
Figure 5; replacement pin above pulleys.

Remove the bolt above the aileron cable pulleys at the leading edge junctions in the cabin, remove and discard the spacer, and insert the 75mm long pin, Figure 5. If this is too tight, run a 6mm drill or reamer through the holes to ease the fit. Secure the pin with a nappy pin or split ring in front of the upright tube. Removal of this pin allows the aileron cables to be removed from the pulleys when de-rigging, as otherwise the large aileron cable end on the port cable cannot pass around these pulleys.
