BRITISH MICROLIGHT AIRCRAFT ASSOCIATION SERVICE BULLETIN

Reference: BMAA Service Bulletin 1918 Issue 3
Title: Mandatory Inspection following fatal accident in Norway
Applicability: All UK MXP-740 Savannah Classic and Savannah VG aircraft
Author: Adrian Jones, Design Approval Engineer, BMAA
Effective date: 29 December 2010
Classification: Mandatory (mandated by UK CAA Mandatory Permit Directive)

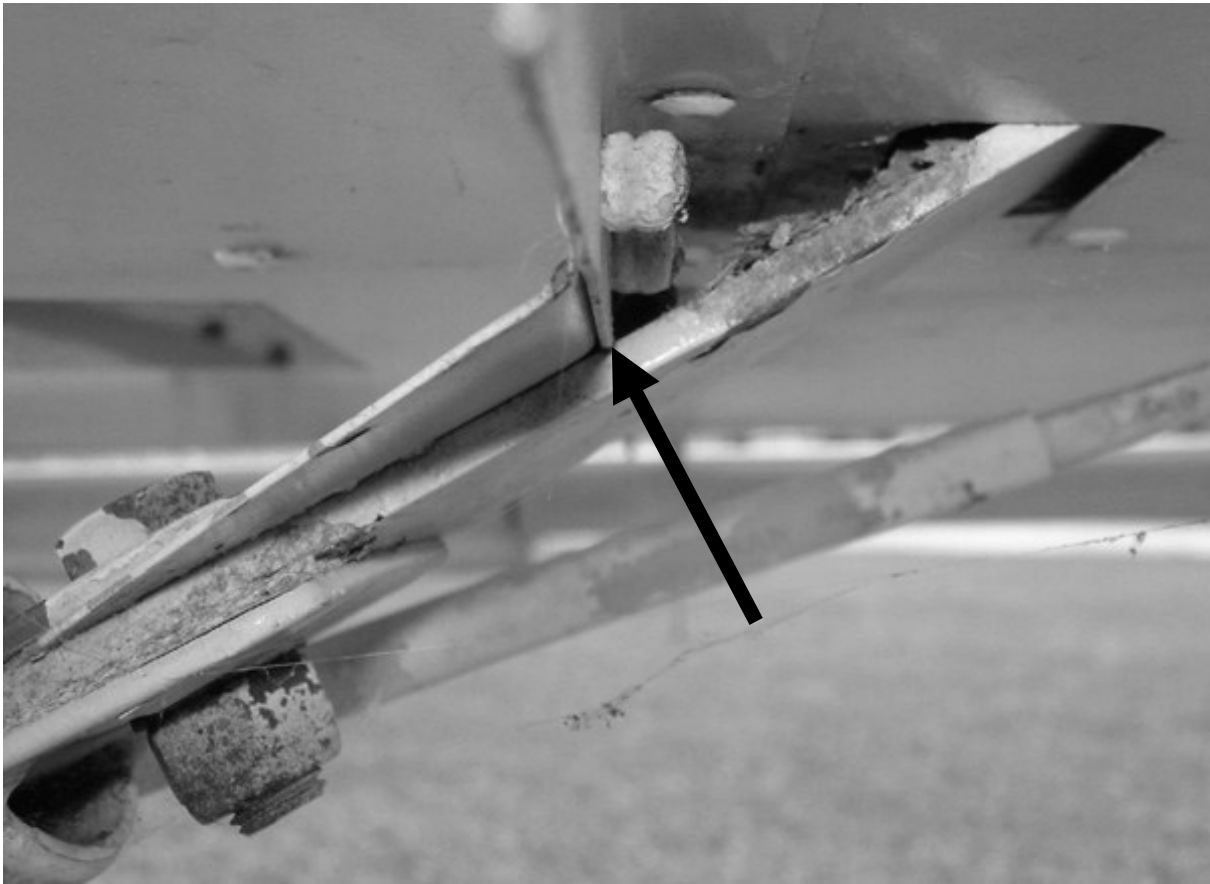
More recently, during an annual inspection of another UK Savannah, a BMAA inspector discovered severe inter-granular corrosion of the attachment plates. (See Appendix A Photo 1). This should normally have been picked up by the pre-flight checks. This aircraft was also tethered outside.

Photo 1: Severe inter-granular corrosion of the attachment plates and fittings. Also potential site of fretting is marked with an arrow.

If defective parts are found, including corrosion other than mild surface oxidation, do not fly the aircraft and contact the BMAA immediately for further advice.

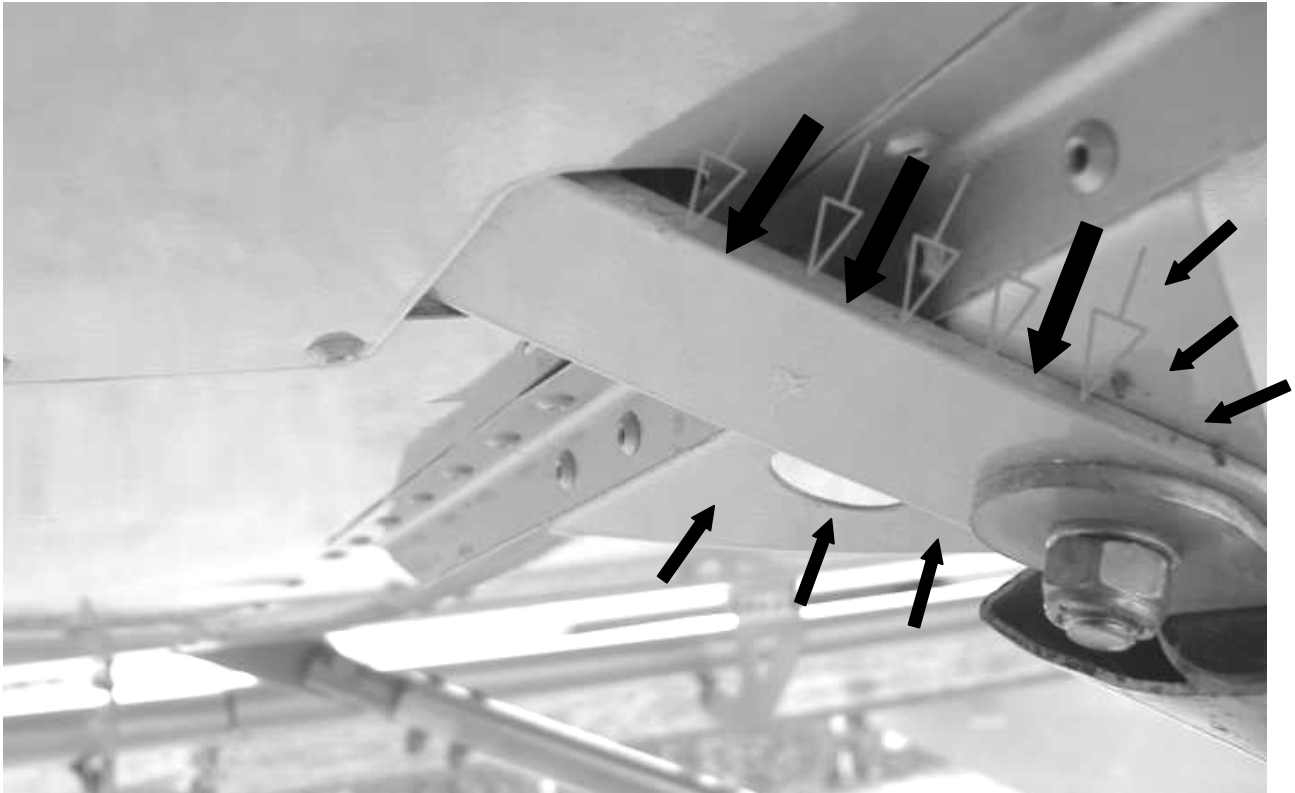
Photo 2: The large arrows point out the side of the main lift strut attachment plate, whilst the smaller arrows point out the fixing plate; all sides of which also need to be thoroughly inspected.

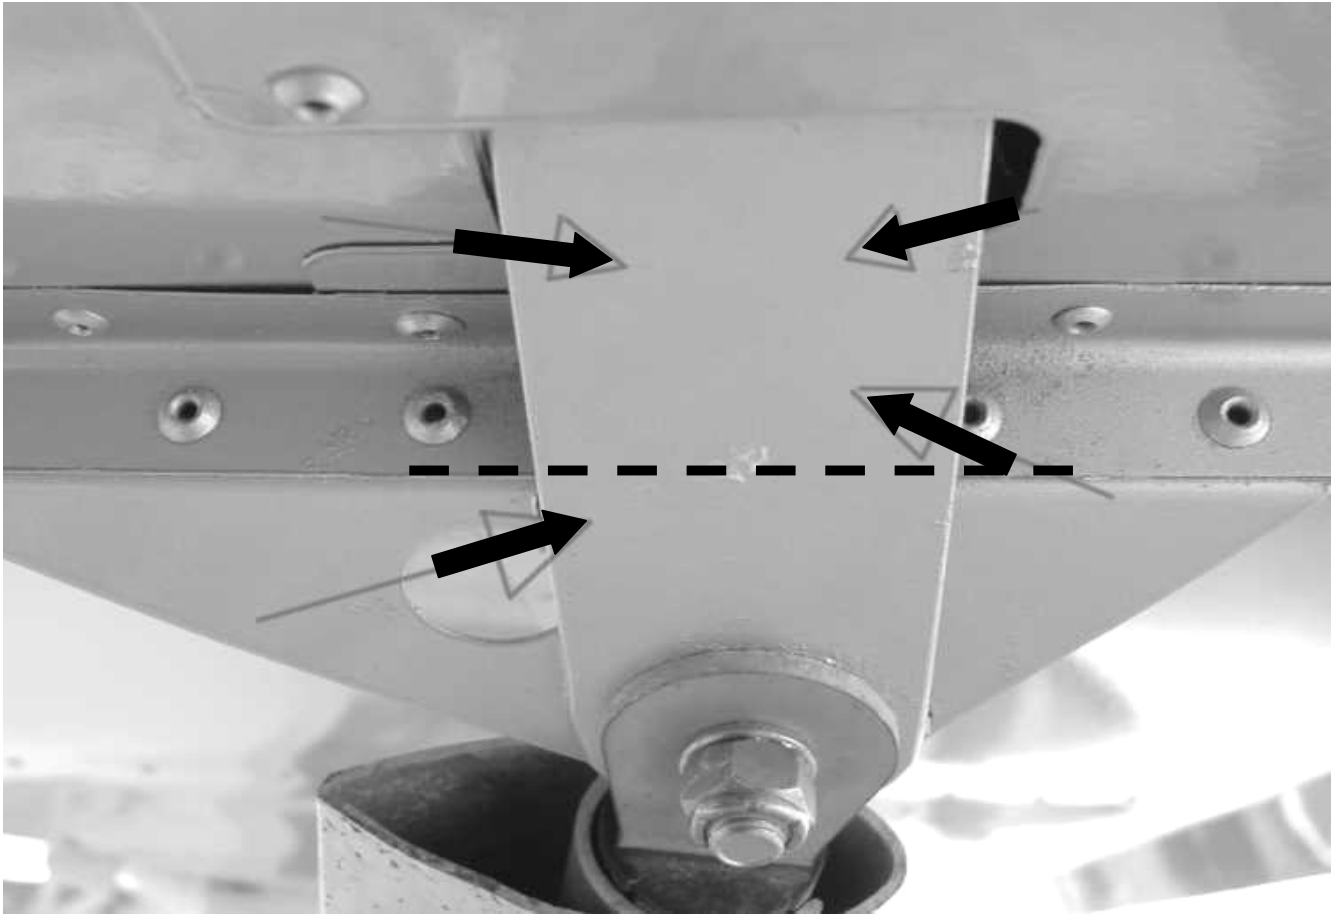
Attention should be paid to the areas marked on the photographs to be found in Appendix A. A particular point to check is the wing lift strut attachment plates' upper surface for fretting due to contact with the adjacent bracket (as shown in Photos 1 and 3).

Photo 3: The four arrows here point out the underside of the lift strut attachment plate; the topside should also be inspected. Pay particular attention to the topside of the plate in the area marked by the dashed line and ensure that no fretting has taken place between the plate and the adjacent angle.

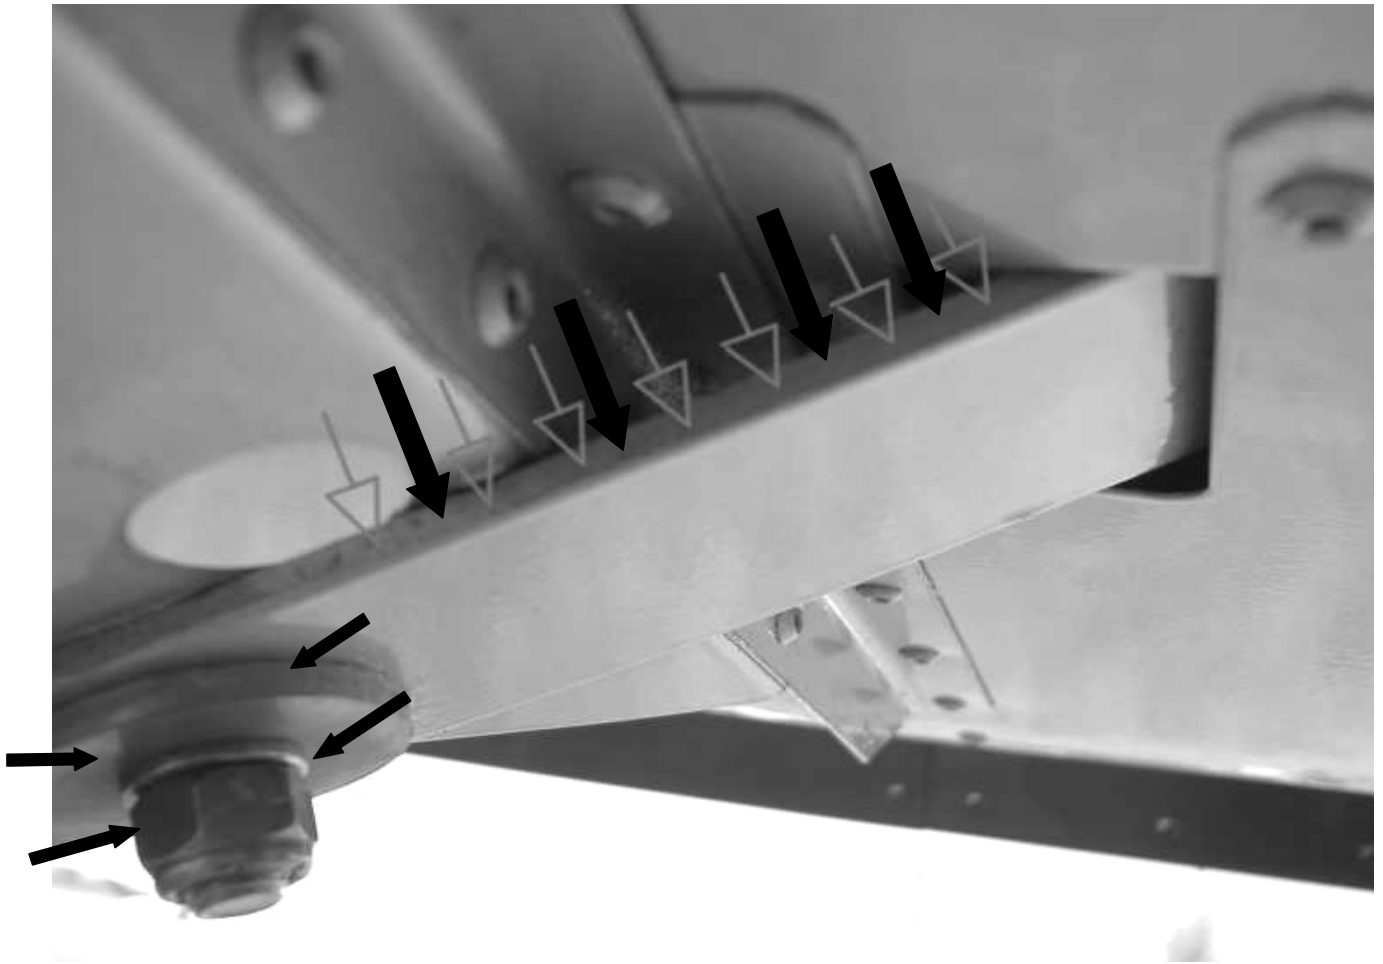
Photo 4: The larger arrows here point out the rear side of the lift strut attachment plate, whilst the smaller arrows point out the fixings with which the lift strut has been attached.

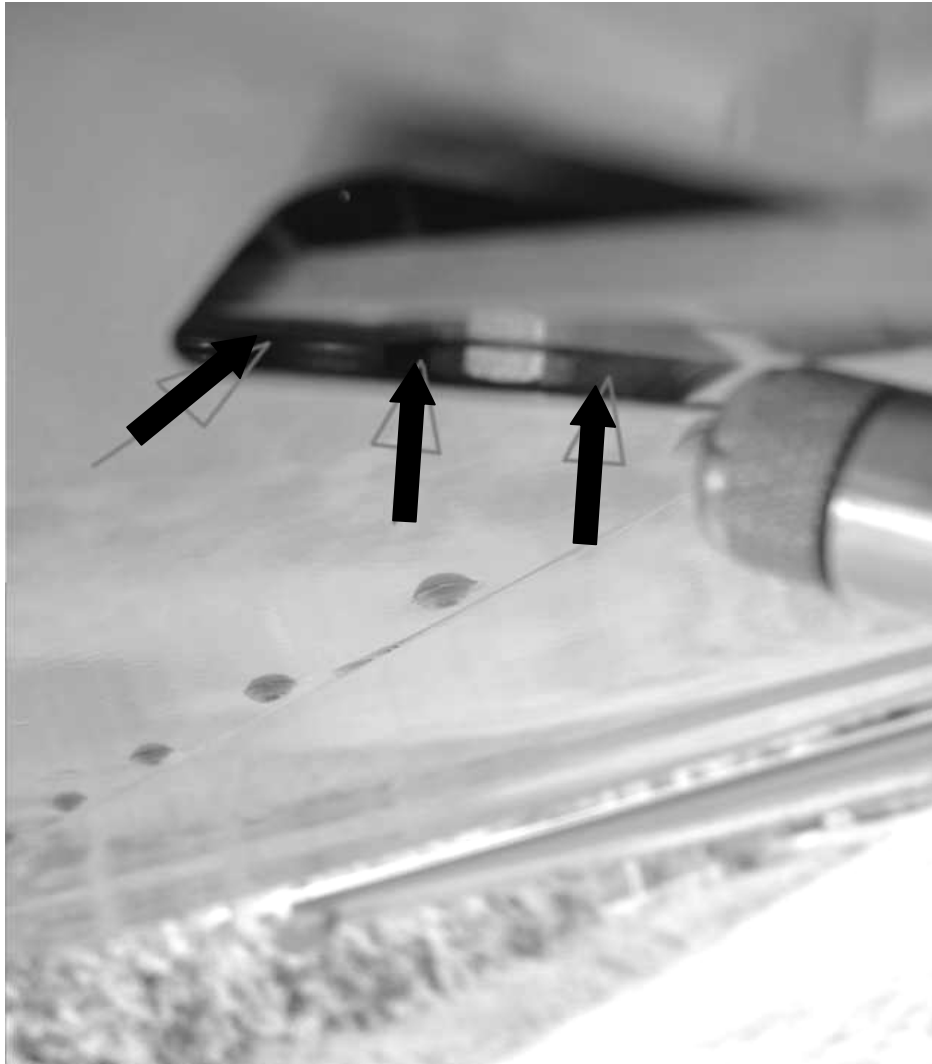
Photo 5: The three arrows here point out the section of the lift strut attachment plate and its fixings that are to be found inside the wing. The torch should be used to aid inspection of these internal parts.
