## MICROLIGHT AIRWORTHINESS APPROVAL NOTE

MAAN NO: 2000

TITLE: Microlight Airworthiness Approval Note 2000,  
Skyranger – Service Bulletins 2000/1, 2000/2 and 2000/3.

Applicability: SB2000/1 – UK Skyranger aircraft with CKT exhaust (Rotax 912 and 912S variants)  
SB2000/2 – All UK Skyranger aircraft  
SB2000/3 – UK Skyranger aircraft with Kiev propellers

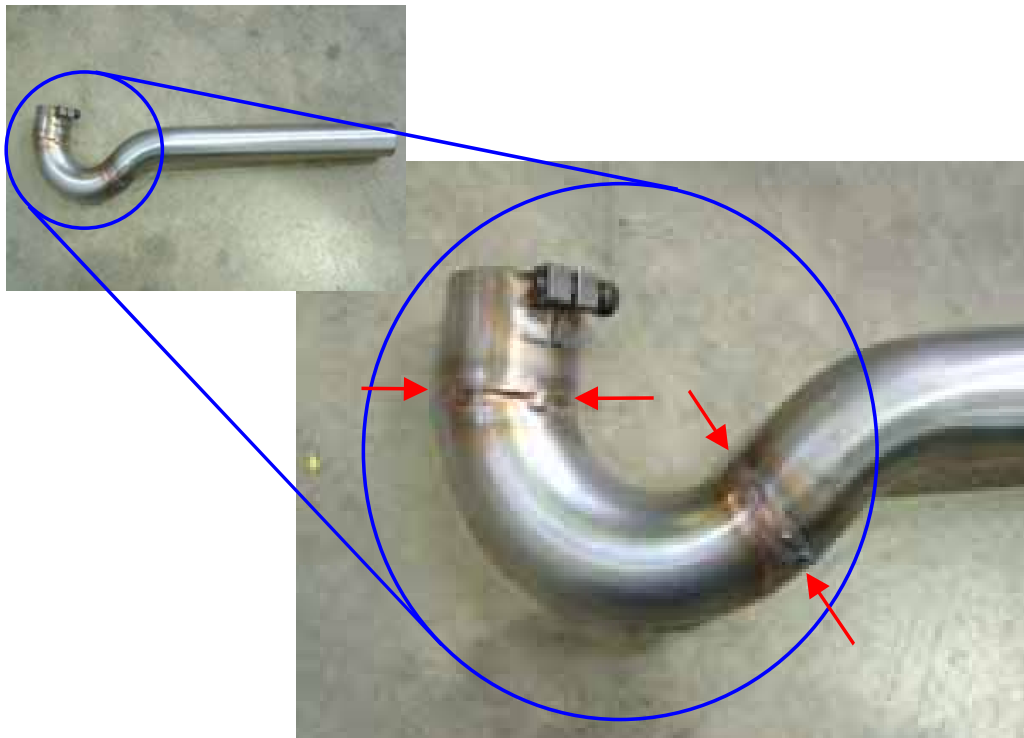
Instances of cracking of the tailpipe on CKT exhausts have occurred on Rotax 912S Skyranger variants. This problem has been reported on some examples after less than 100 hours. No such failures have been reported on 80hp Rotax 912 variants to date. The cracking may be due to start-up shake, which is noticeably more fierce with the Rotax 912S than with the 912.

The cracking occurs around two welded seams on the tailpipe downstream of the exhaust box on CKT exhausts – see appendix A for more details. The exhaust manufacturer has developed a corrective modification in the form of a ‘steady bracket’.

The welds on the exhaust tailpipe highlighted in figure 1 must be carefully inspected for cracks. A bright torch should be used to illuminate the welds. Cracks of any length require remedial action to be taken.

**Figure 1: CKT exhaust tailpipe highlighting the two welded seams prone to cracking**

1. Before further flight carefully inspect the tailpipe for cracking. If any cracking is evident do not fly the aircraft, remove the exhaust and return it to CKT for remedial action and modification. If there is no cracking an entry must be made in both the airframe and engine logbooks stating that "***The initial inspection part of BMAA Service Bulletin 2000/1 (inspection and modification of CKT exhaust) has been carried out***", along with the name, qualification and signature of the person implementing the service bulletin. Note that it may be necessary to remove the lower cowling to perform a thorough inspection.

3. Within the next 10 hours, or before the next permit renewal if sooner, remove the exhaust and return it to CKT for modification. On its return, re-install the exhaust. An independent inspection of the re-installed exhaust, by an inspector or another pilot, is required before further flight.
4. An entry must be made in both the airframe and engine logbooks stating that *“BMAA Service Bulletin 2000/1 (inspection and modification of CKT exhaust) has been carried out”*, along with the name, qualification and signature of the person implementing the service bulletin.

This area can typically be satisfactorily inspected with removal of the top engine cowling only, because the underside of the welds can either be viewed from below the aircraft through the gap at the rear of the lower cowling, or from above using a mirror. However some installations may benefit from removal of the lower cowling in order to perform a thorough inspection of the problem area.

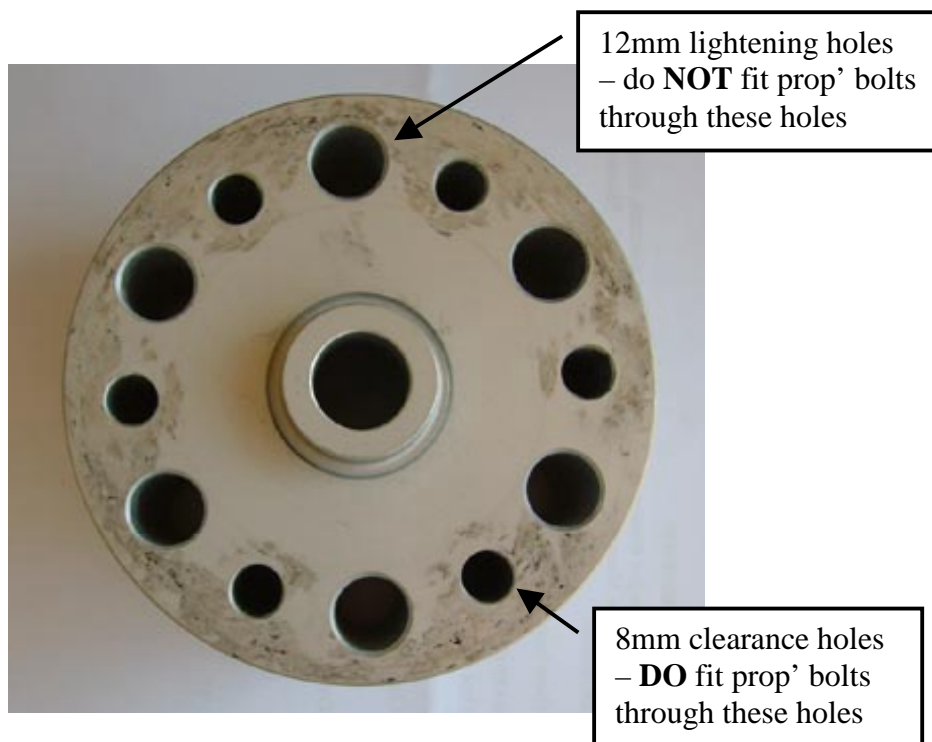
Some Kiev propeller spacers contain large diameter lightening holes in addition to the clearance holes for the propeller bolts – see appendix A for more details. It is possible to incorrectly install the propeller spacer with the propeller bolts through the lightening holes instead of the clearance holes. This puts bending loads through the propeller bolts (rather than pure shear loads), which cause premature failure of the bolts.

**Figure 1: Affected Kiev propeller spacer highlighting the 8mm clearance holes and the 12mm lightening holes**

1. Before further flight remove the propeller and check that the propeller bolts have been correctly installed through the clearance holes in the propeller spacer, not through any larger diameter lightening holes.

2. If the propeller was incorrectly installed check for any damage to the propeller flange (on the prop' shaft emanating from the engine/gearbox), spacer and propeller hub. If any damage is found contact the BMAA for advice.

3. Re-install the propeller using the instructions supplied with the propeller: these should be at annex G to the operator's manual, or a copy can be obtained from Flylight Airsports Ltd. In particular ensure that the correct torques are used and that the propeller bolts are safety wired in place to avoid them loosening in service. If the propeller was incorrectly installed new propeller bolts **must** be used and the old bolts disposed of. New bolts are available from Flylight Airsports Ltd.
