MICROLIGHT AIRWORTHINESS APPROVAL NOTE

MAAN NO: 2013

TITLE: Microlight Airworthiness Approval Note 2013, Savannah – Service Bulletin 2013: modification of rear cross-member

Applicability: All Savannah aircraft

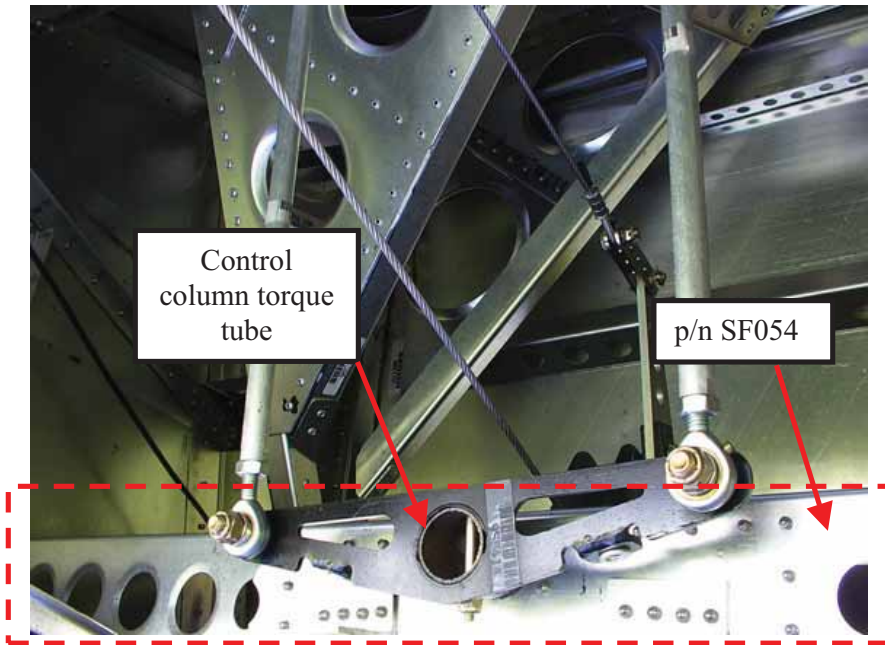
Figure 6: General location

The area to inspect is accessed through the panel in the lower rear fuselage section, just aft of the cockpit. The pecked box in the above photograph highlights the cross-member SF054.

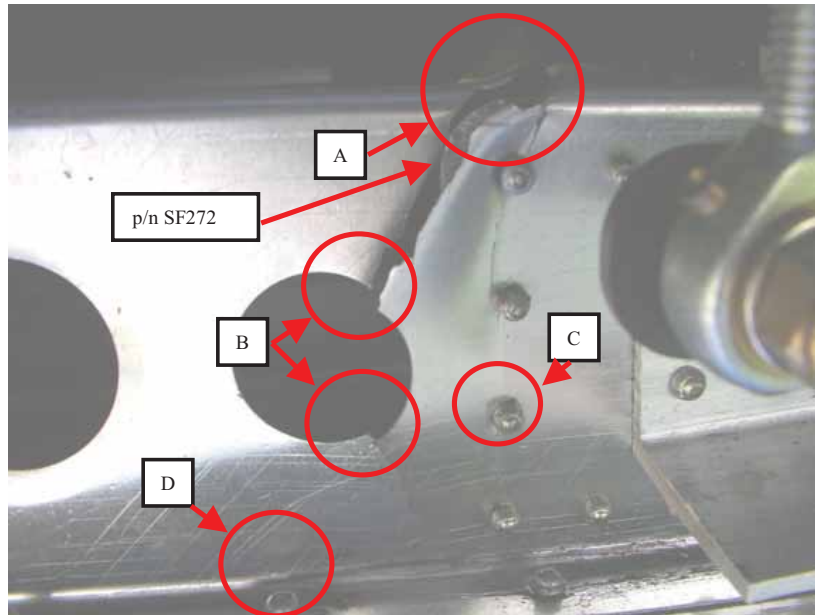
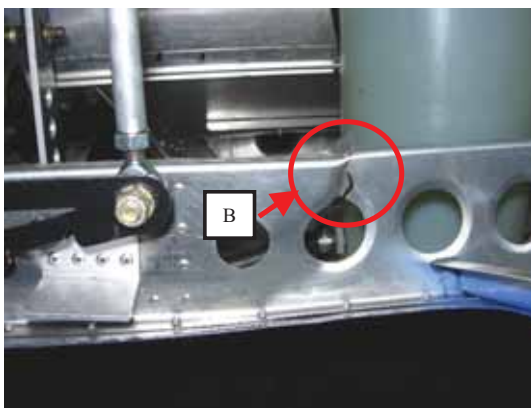
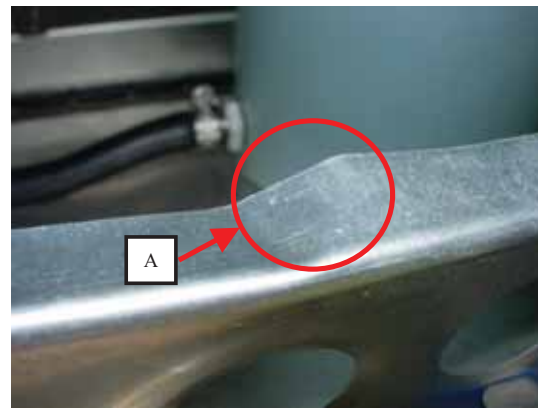
Figure 7: Areas to check

A: The top flange. Check for any bends, buckling or cracks. The flange should be flat all the way across. Check for cracks on the inside (forward face) of the bend radius.

B: The lightening holes. Check for cracks anywhere around the edge of each hole (note that all holes should be checked on each side of the aircraft).

C: The rivets. Check for cracks emanating from the rivet holes, particularly where the reinforcement plate SF272 attaches. Check that the heads of the rivets are on the aft face (this illustration shows the tail incorrectly positioned on the aft face).

D: The bottom flange: Check for any cracks in the inside bend radius. Check for any cracks emanating from rivet holes.
