MICROLIGHT AIRWORTHINESS APPROVAL NOTE

MAAN NO: 2073

TITLE: Microlight Airworthiness Approval Note 2073,
Shadow Service Bulletin BMAA 2073.

Applicability: All Shadow variants

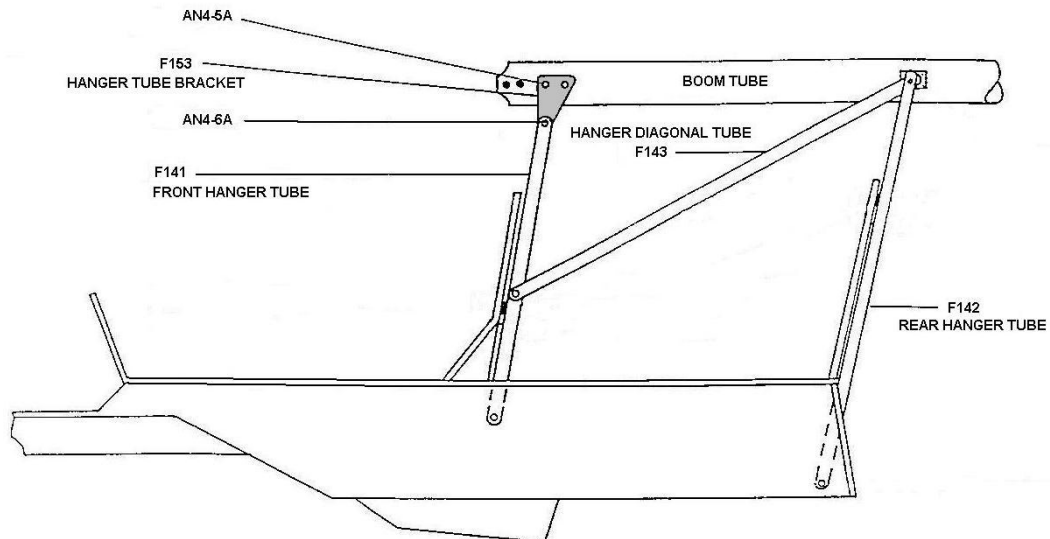
Following a cracking failure of a F153 Hanger Tube Bracket on an aircraft in Argentina, the following inspection has been introduced to monitor these brackets to see if a significant problem exists. There have been no reports in the UK of any such failure of these brackets.

Part F153 Hanger Tube Bracket, which attaches the front hangar tube to the boom tube.

1. Firmly chock the main wheels to prevent them moving during the inspection.
2. From the rear cockpit, equipped with a good light source, inspect the F153 plates for cracks and any evidence of movement or fretting within the hanger tube and the bolts for tightness.

3. Whilst inspecting the plates, ask a helper to gently push the wing fore and aft and check visually, and by feel, for any signs of movement between the plate and the hanger tube.

4. Next try using a firm vertical force applied at the point where the wing strut attaches to the wing. **WARNING:** do not exert lifting pressures at the wing tip.

5. Repeat steps 3 & 4 on the other wing.
6. Any evidence of undue movement or fretting should be investigated. If unsure, the F153 may be removed from the aircraft for a detailed inspection. If everything appears normal, then return the aircraft to service.

7. Any adverse findings should be reported to the BMAA.
