MICROLIGHT AIRWORTHINESS APPROVAL NOTE

MAAN NO: 2159

TITLE: Microlight Airworthiness Approval Note 2159: inspection and modification of the elevator bias spring attachment bracket SUP8

APPLICABILITY: UK Savannah aircraft with the manual (bungee) pitch trimmer fitted

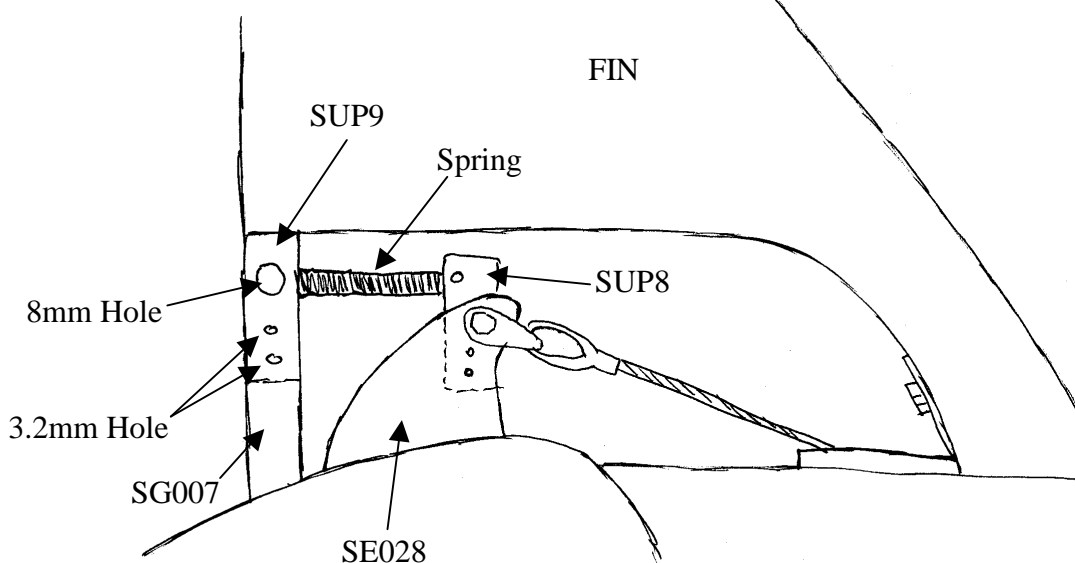
UK Savannah aircraft with the manual (bungee) pitch trimmer fitted have an elevator bias spring mechanism fitted in the tail. See figure 1 in appendix A to the service bulletin. This mechanism includes a plate, SUP8, that is attached to the elevator control horn, SE028. On one aircraft it was discovered that the elevator control cable came into contact with SUP8 at one extreme of elevator movement (elevator fully down; stick fully forward). See figure 2 in appendix A to the service bulletin. This is unsatisfactory because the elevator control cable will wear over time and could eventually fail. As the location of SUP8 on SE028 is not specified precisely in the build manual it is possible that other aircraft have a similar fault.

Figure 1: schematic of elevator 'down' spring installation.

1. Within 10 hours or before the next inspection for revalidation of the Permit to Fly, whichever is the sooner, remove the inspection panel and inspect the attachment of the elevator control cable to the elevator control horn, SE018. See figure 1 in appendix A. The control cable should **not** contact bracket SUP8 through the full range of elevator movement: stick fully forward to stick fully back. See figure 2 in appendix A.

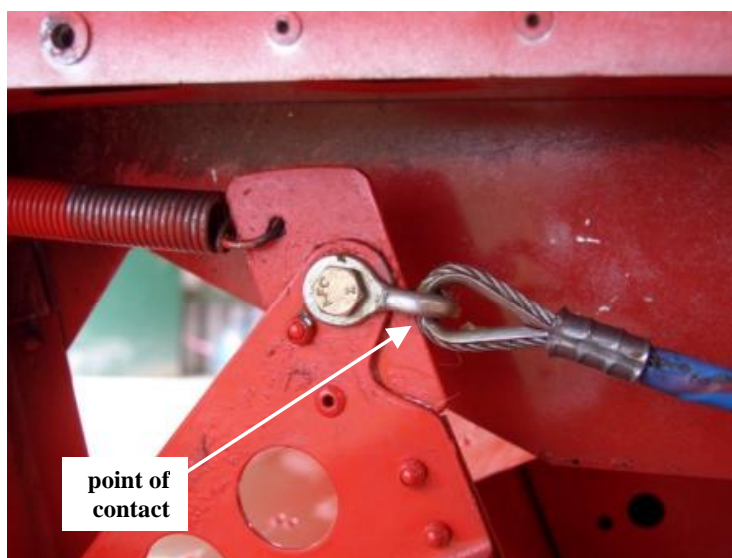
UK Savannah aircraft with the manual (bungee) pitch trimmer fitted have an elevator bias spring mechanism fitted in the tail. See figure 1 in appendix A. This mechanism includes a plate, SUP8, that is attached to the elevator control horn, SE028. On one aircraft it was discovered that the elevator control cable came into contact with SUP8 at one extreme of elevator movement (elevator fully down; stick fully forward). See figure 2 in appendix A. This is unsatisfactory because the elevator control cable will wear over time and could eventually fail. As the location of SUP8 on SE028 is not specified precisely in the build manual it is possible that other aircraft have a similar fault.

Figure 2: photograph showing contact between elevator control wire and SUP8.

- 2.1 To ensure the elevator control cable does not contact SUP8 the elevator cable should be disconnected and SUP8 filed down at the point of contact until the control cable remains clear. The final profile must be smooth without any sharp steps. The filed area should be protected using a non-flexible paint and the elevator control cable reconnected. A new split pin must be used. Under no circumstances must the elevator control horn, SE028, be modified.

- 2.2 If the control cable is damaged – for example if the cable is badly worn or any strand broken – it must be replaced in accordance with the approved build manual. Slight ‘polishing’ or a slight flattening of the control cable at the point of contact is not considered significant.
