MICROLIGHT AIRWORTHINESS APPROVAL NOTE

MAAN NO: 2283

TITLE: Microlight Airworthiness Approval Note 2283: inspection and modification of the elevator anti-balance tab control mechanisms

APPLICABILITY: UK Savannah aircraft fitted with bungee pitch trimmer (Mandatory Modification 12)

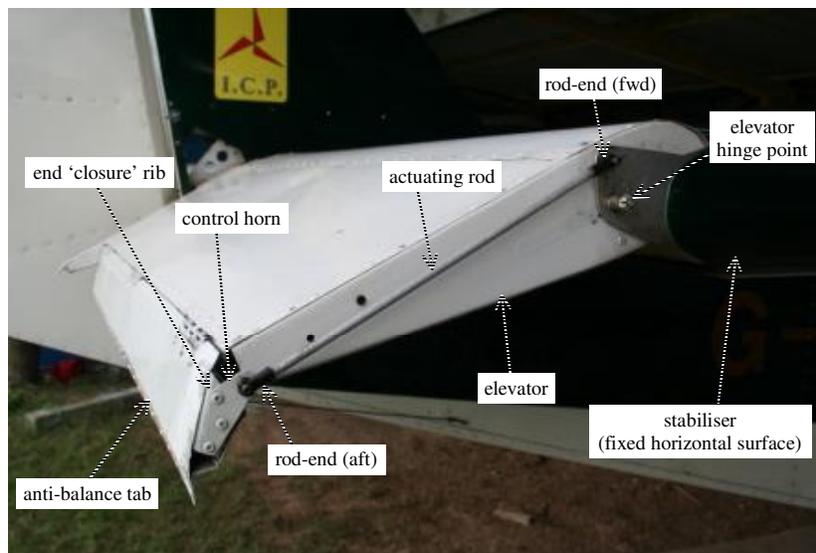
UK Savannah aircraft have two anti-balance tabs fitted to the trailing edge of the elevator (one on the port side and one on the starboard side). Each anti-balance tab has its own control mechanism located at the outboard end of the elevator and protected by a fairing. Figure 1 shows the control mechanism for the starboard anti-balance tab.

Figure 1: View of starboard end of starboard elevator with fairing removed to show the anti-balance tab control mechanism. This aircraft has manual, 'bungee', pitch trim fitted. The control horn is riveted to the end 'closure' rib. The end 'closure' rib is riveted into the end of the anti-balance tab (upper and lower surfaces).

Within 3 months of the effective date of this service bulletin the plastic rod-ends must be replaced with metal rod-ends. The metal rod-ends are provided by Sandtoft Ultralight Partnership together with fitting instructions. This modification does not stop the requirement for careful pre-flight inspection.

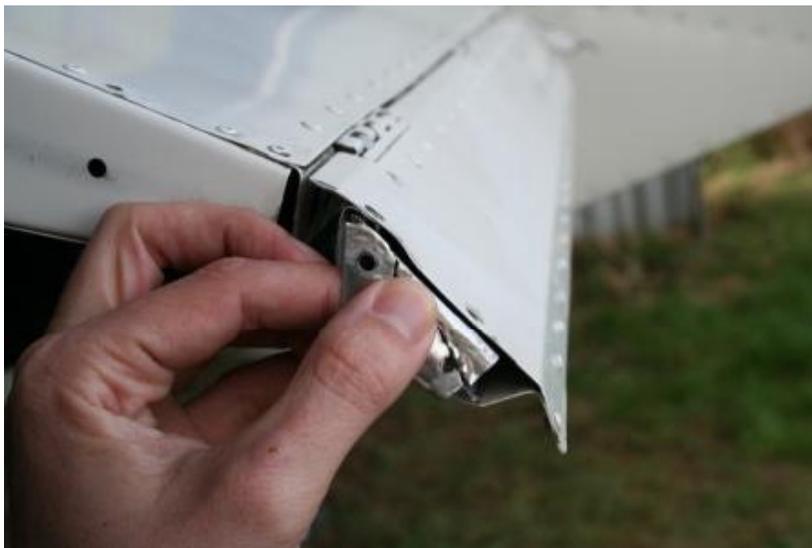
- To port, the end 'closure' rib fractured so that the control horn was no longer positively attached to the anti-balance tab. Figure 2 shows the fractured end 'closure' rib.
- To starboard, a rod-end on the actuating rod failed. The rod ends are plastic retaining a brass bush. The plastic had enlarged so that the bush was no longer retained.

Figure 2: Fractured end ‘closure’ rib held in original position in port end of port anti-balance tab. The rivets attaching the control horn in place on the end ‘closure’ rib, and the rivets attaching the end ‘closure’ rib to the anti-balance tab, were drilled out subsequent to the in-flight failure.

Following an investigation it is considered likely that the root cause of the problem is the anti-balance tab operating mechanism. The design of the mechanism is such that at full up elevator the anti-balance tab gearing becomes infinite and therefore prone to being strained. In particular, at full up elevator the anti-balance tab can attempt to go ‘over-centre’. The tip fairing stops the anti-balance tab going far over-centre, but it can go far enough for the mechanism to be strained as the elevator is lowered forcing the anti-balance tab to jump back into its correct position.

It is considered that the original failure was probably due to fatigue (either of an anti-balance tab end ‘closure’ rib or a plastic rod end) following damage to the mechanism. Therefore the inspection specified by this service bulletin should catch future problems before they result in another in-flight failure.

- Carefully inspect the end ‘closure’ ribs for any signs of cracking, deformation or other damage. Ensure that no rivets – either those attaching the control horn to the end ‘closure’ rib, or those attaching the end ‘closure’ rib to the anti-balance tab – are loose. This inspection requires good illumination: use a bright torch if necessary.
- Only the aft rod-ends on the actuating rods can be visually inspected for deformation or other damage because of the elevator tip fairings. Therefore carefully check for any play (backlash) in the actuating rod-ends indicative of a loose bush. Perform this by holding the elevator steady with one hand while attempting to move the trim tab trailing edge up and down with the other.

By 31 December 2011 the anti-balance tab operating mechanism must be modified to eliminate the problem using an approved modification. At the time of writing the only such approved modification is the UK Savannah electric trim (approved optional modification 4). However the BMAA is happy to assess other modifications to eliminate the problem with the anti-balance tab operating mechanism without removing the bungee trim.
