## MICROLIGHT AIRWORTHINESS APPROVAL NOTE

MAAN NO: 2298

**TITLE:** Microlight Airworthiness Approval Note 2298: inspection and replacement of turnbuckles in the aileron control lines.

**APPLICABILITY:** Raj Hamsa X'Air and X'Air Falcon

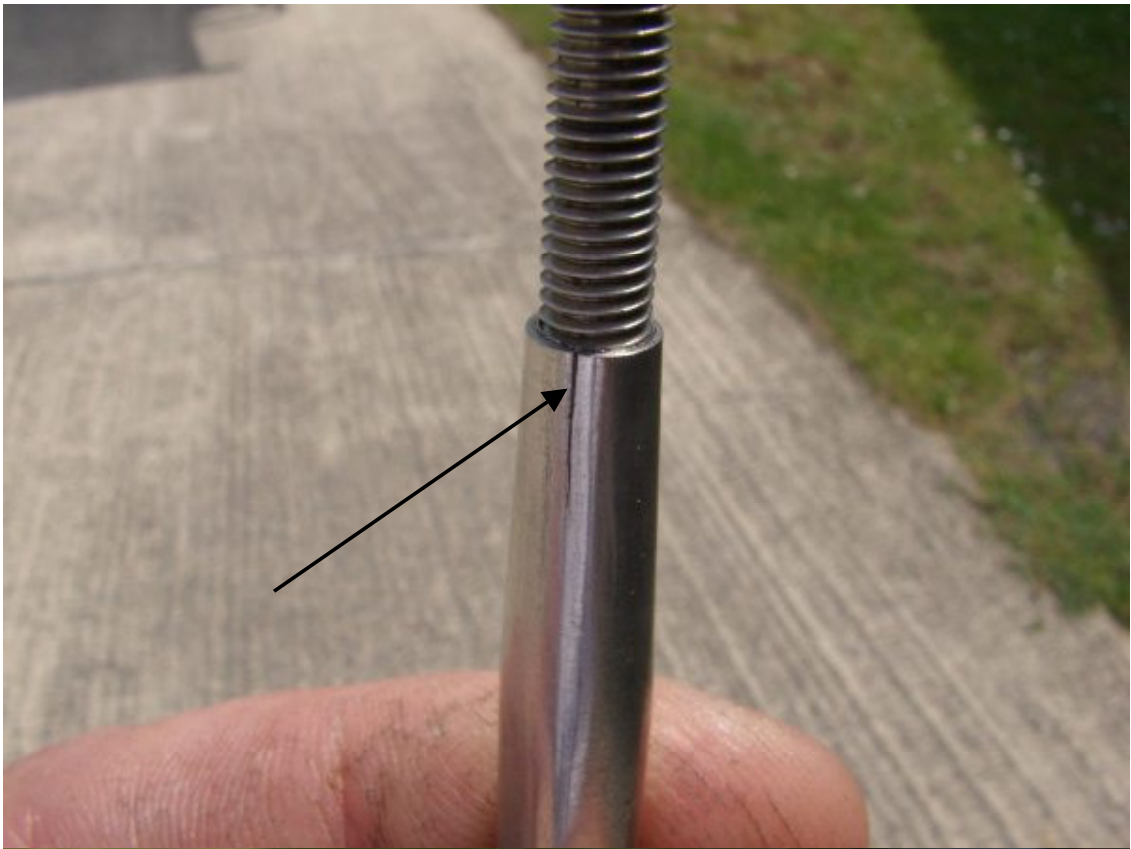
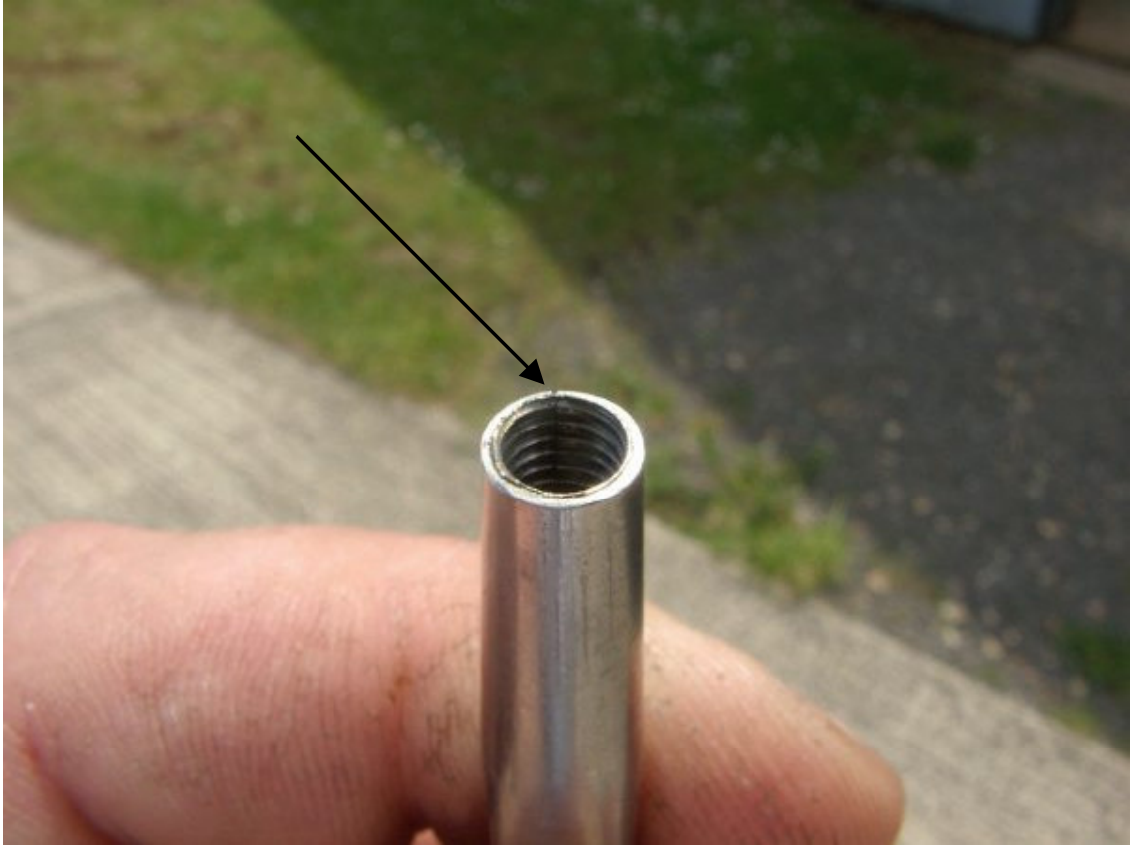
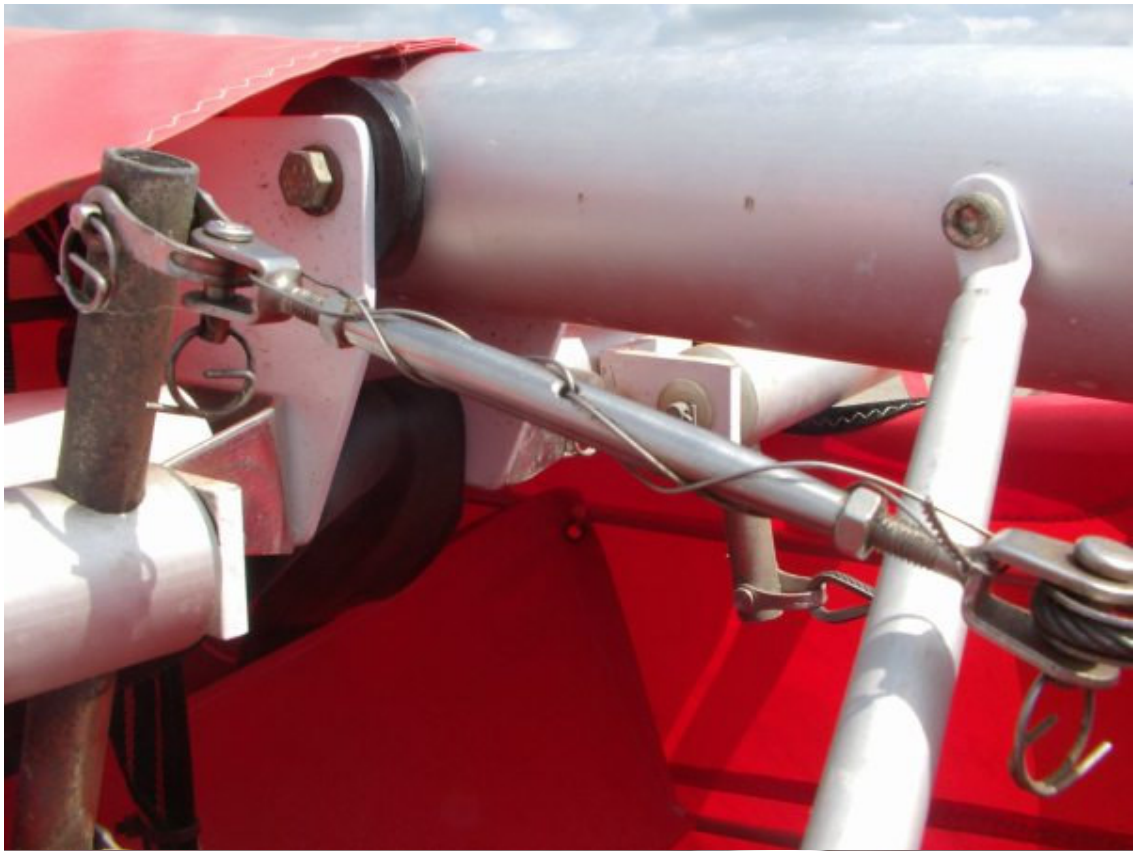
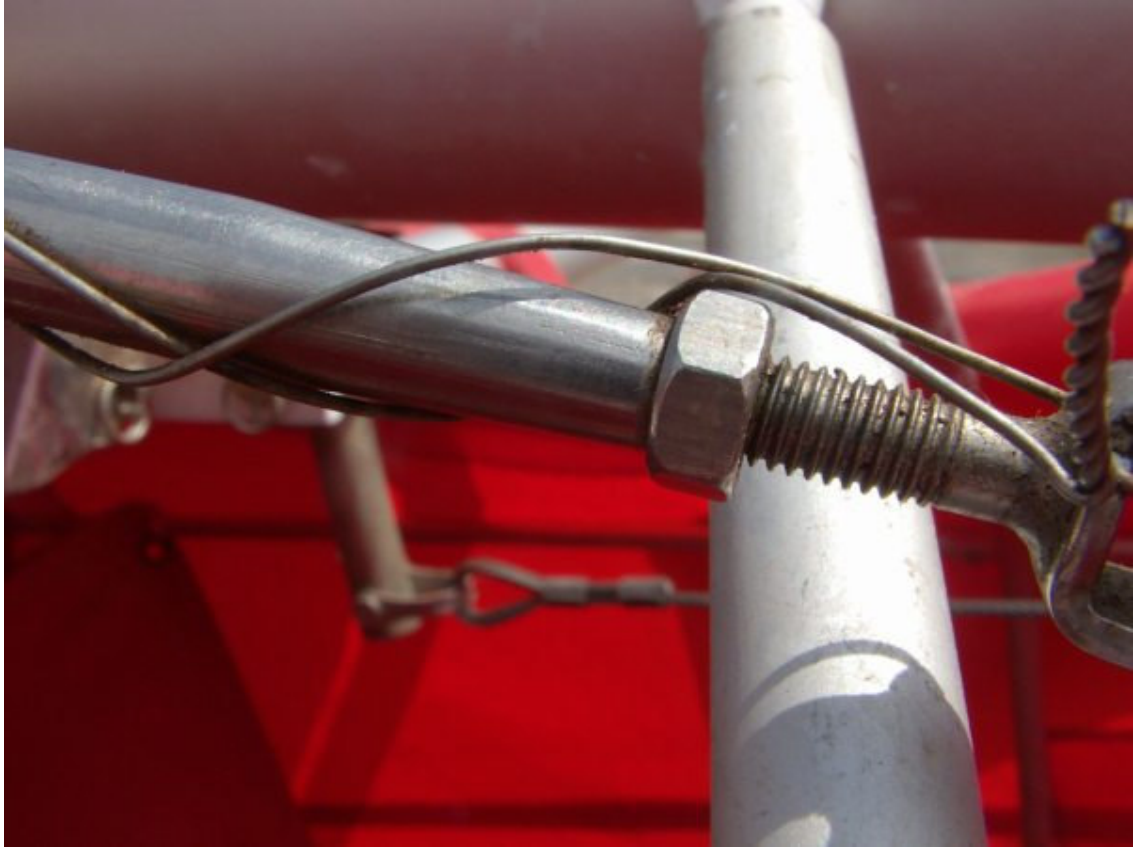
7. Images

It was recently reported by one of our inspectors that an aileron turnbuckle on an X' Air had witness marks from the tooling / extrusion process. One mark appeared to have developed into a crack. Once the turnbuckle was removed and inspected it could be clearly seen that the crack went all the way through and for the entire length of the thread. See the accompanying images.

All the turnbuckles were different, as the tolerances seemed to vary considerably. The cracked one had a taper that made the threaded area very thin. This is from the manufacturing process and not from any wear or damage. New turnbuckles, sourced directly from X'Air, also have the manufacturing marks on them.

Any cracked turnbuckles must be replaced before the next flight. Also any that have deep tooling marks must be replaced. Replacement turnbuckles must be sourced from the Wessex Light Aeroplane Company.
