MICROLIGHT AIRWORTHINESS APPROVAL NOTE

TITLE: Microlight Airworthiness Approval Note 2329: Shadow Tailplane Spar and Bush Wear

BRITISH MICROLIGHT AIRCRAFT ASSOCIATION SERVICE BULLETIN

Reference: BMAA Service Bulletin 2329 Issue 1
Title: Horizontal tail plane spar wear
Applicability: All BMAA-administered Shadows
Author: B J Syson, Chief Technical Officer, BMAA
Effective date: 21 March 2011
Classification: Essential

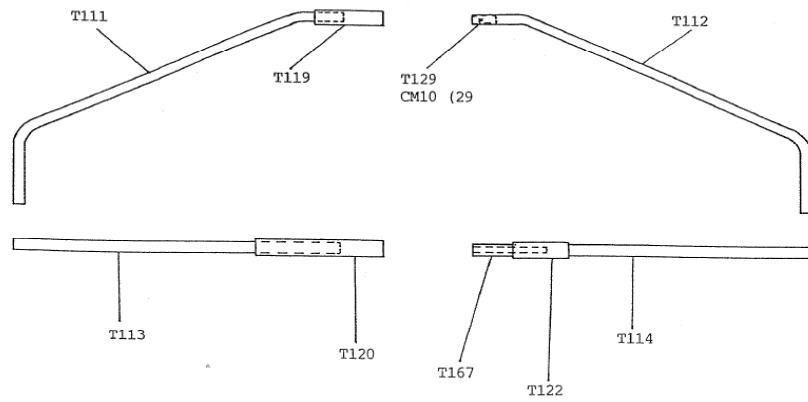
Figure 1: Shadow horizontal tail plane structure

Parts T119 and T120 are affected – see Figure 1. An example of extreme, and totally unacceptable, wear is shown in Figure 2. Two distinct wear patterns may be seen, caused by contact with the bushes and with the fuselage tube.

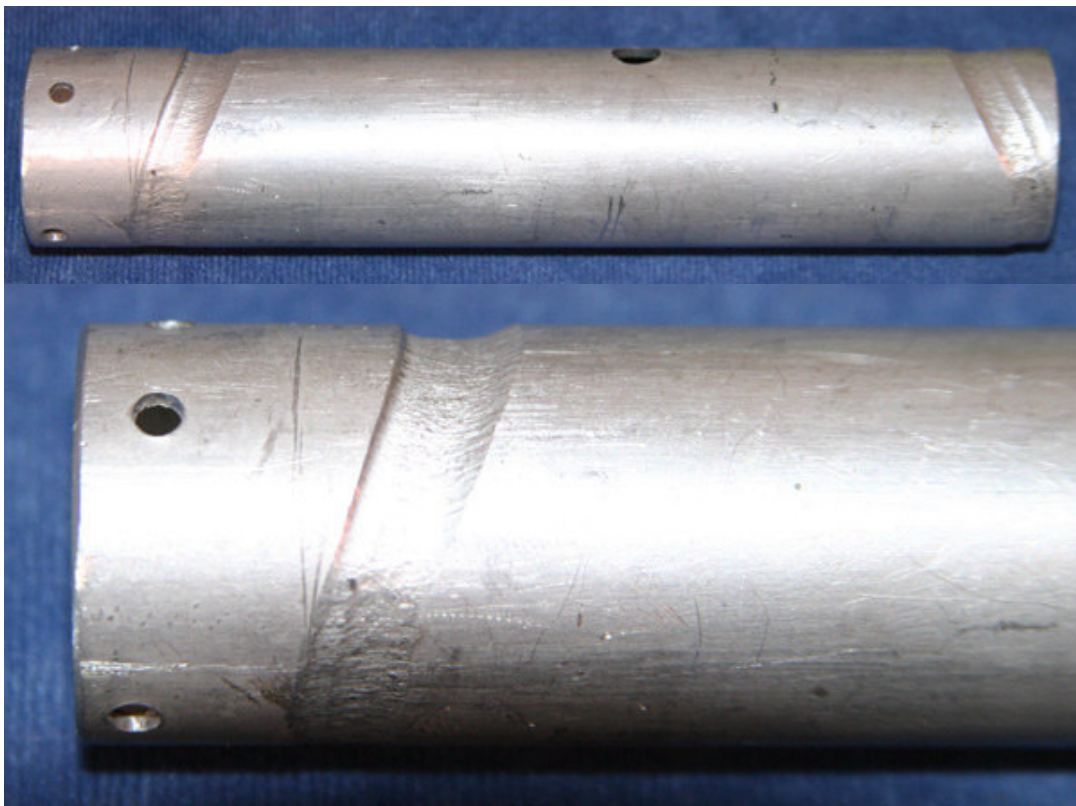
Wear of the spars in excess of 0.6mm (0.024") is totally unacceptable from a strength perspective. However wear less than this may also be unacceptable if (possibly combined with wear of the locating bushes) it results in significant 'slop'.

Figure 2: an example of extreme, totally unacceptable wear

Any repairs must be made in full accordance with BMAA procedures – contact the BMAA Technical Office.
