MICROLIGHT AIRWORTHINESS APPROVAL NOTE

MAAN NO: 2336

TITLE: Microlight Airworthiness Approval Note 2336: Shadow Fuel Tank Deterioration

Reference: BMAA Service Bulletin 2336 Issue 1
Title: Fuel Tank Deterioration
Applicability: All BMAA-administered Shadows
Author: Adrian Jones, Design Approval Engineer, BMAA
Effective date: 21 March 2011
Classification: Essential

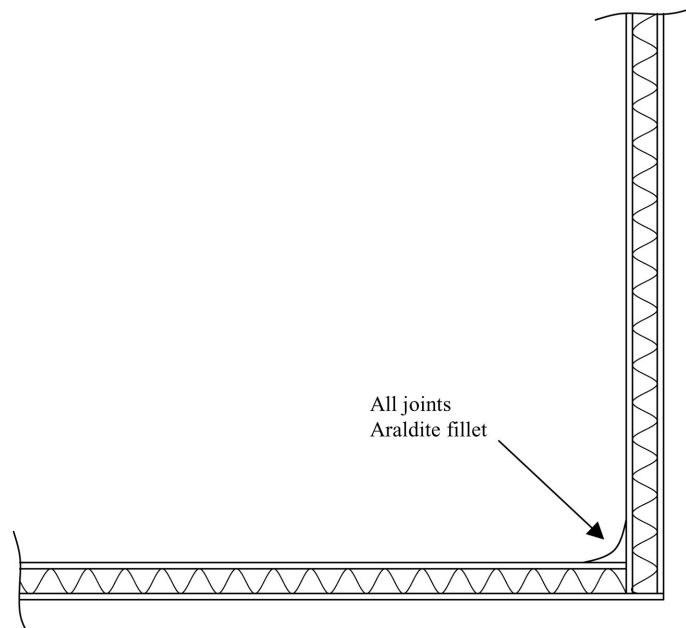
They are constructed from flat 1/8" thick panels, rebated and bonded together at their edges with epoxy. Figure 1 shows a typical edge joint showing a neat fillet of epoxy. After assembly, but before the top is bonded on, the interior of the tanks is coated with a thin layer of epoxy. The fuel outlet hole is then screened by a plastic 'tea strainer' bonded onto the floor of the tank. After bonding on the top a small amount of epoxy is poured into the tank to coat the top panel. It is not possible to neatly fillet the top edge joints as with the rest of the tank.

Figure 1: Shadow Fuel Tank Construction

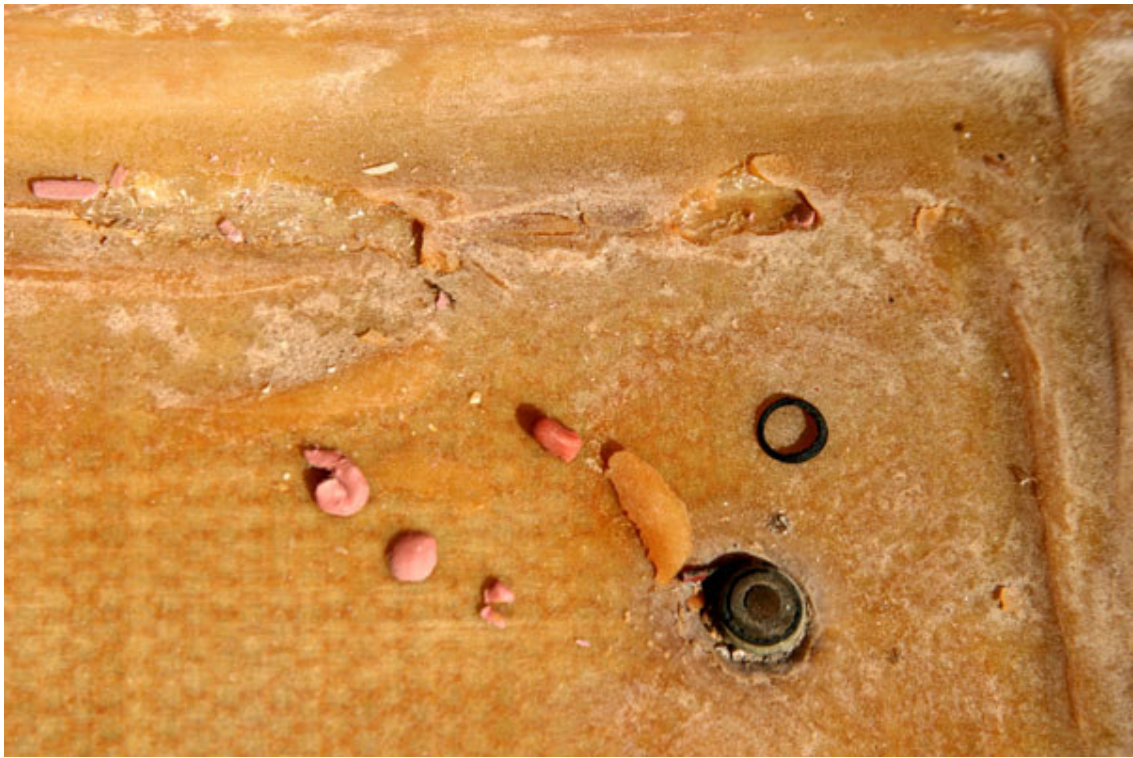
In a number of examples the tanks have developed leaks at the bonded edges. Also fragments of epoxy have been found and the strainer has become dislodged. In one known case the strainer gauze had disintegrated leading to an engine failure, due to debris entering the fuel line. See Figures 2 & 3. Both the main and slipper tanks have been affected.

It is thought that the deterioration of the tanks and strainers is partly a function of the age of the fleet but mostly the introduction of ethanol into fuel in recent years. This is born out by a very thorough scientific study commissioned by the American boating magazine, Seaworthy, published by the US Marine Insurance Industry. This can be found at <http://www.boatus.com/seaworthy/fueltest.asp#>.

Once the tank has developed a leak it is very difficult to carry out a lasting repair since the joints will have been contaminated with 2-stroke oil. Also without removing the top panel, which is a recognised way of opening up the tank, it is impossible to repair the joint fillets effectively from the inside, or to replace the strainer. Removing the top panel is difficult to do without damaging the edges of both the top and sides of the tank.

Figure 2: Debris and Deterioration of Edge Joint

As part of the *daily inspection* the fuel tanks should be checked externally for leaks. The colour imparted to the fuel by the 2-stroke oil often leaves an obvious trail. Otherwise use of a tissue will confirm any suspicion of a leak at a seam. The aircraft should not be flown with a leaking fuel tank.

Within **10 flight hours or 3 months** of the effective date (whichever is sooner), and then at least every **50-flight hours or annually** (whichever is sooner), check that the fuel strainer in the main tank, and the slipper tank if fitted, is intact and bonded in place, and that it is effective at straining out any particles in the fuel. For the main tank, shine an LED torch into the filler neck, but remember to turn it on and off away from the tank to eliminate the possibility of sparks igniting the fuel. For the slipper tank, remove the fuel gauge sender unit and inspect the strainer through the aperture. The aircraft should not be flown if a strainer is not doing its job effectively.

At the same time check for the presence of any particles of epoxy or other debris in either tank. If any are found they should be flushed out with clean fuel until no loose debris remains. Ensure that this is done in an open, well-ventilated area away from any possible source of ignition.

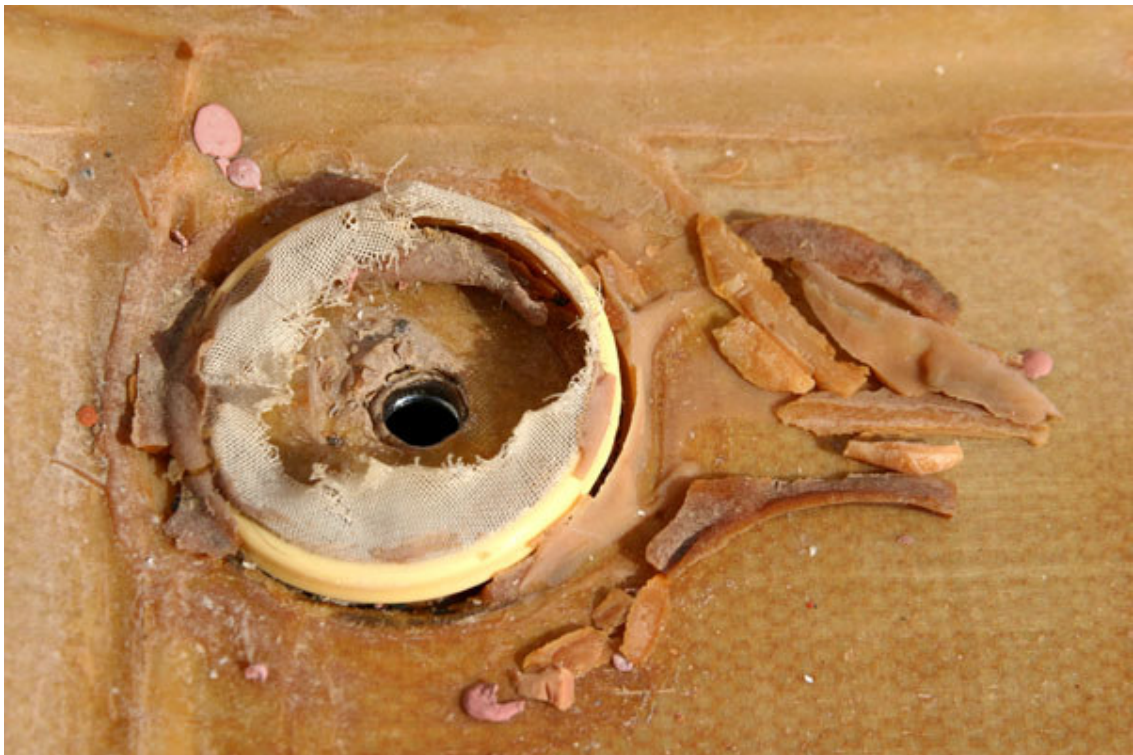
Figure 3: Debris and Strainer Disintegration
