Reference: BMAA Service Bulletin 2443 Issue 1
Title: Inspection of Kievprop composite propeller blades
Applicability: All Kievprop composite propellers
Authors: Adrian Jones & Ben Syson, BMAA
Effective date: 1 August 2013
Classification: Advisory

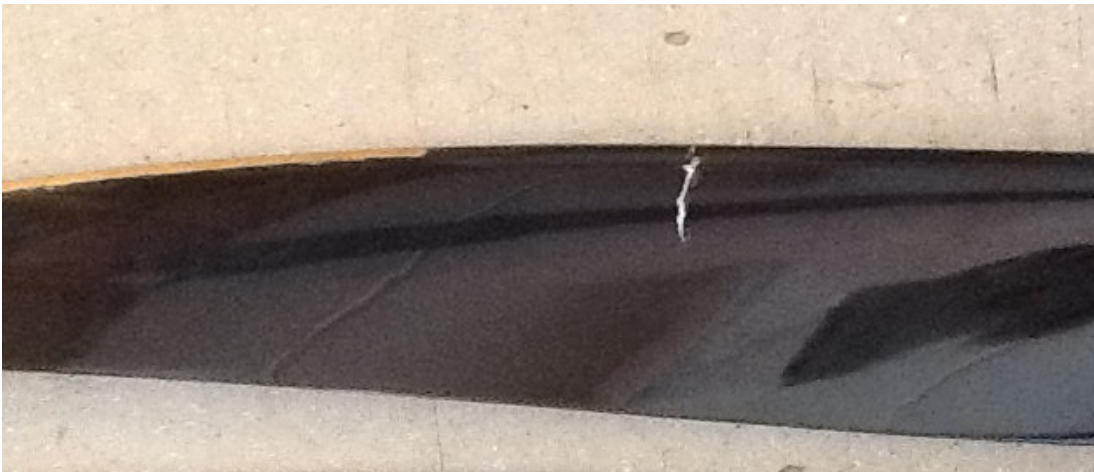
The BMAA has received 2 reports of transverse cracks on Kievprop type 283 (tractor) blades similar to that in Figure 1. This damage may be caused by overload in bending caused, most likely, by hangar rash. It is also possible that the cracks could be fatigue cracks caused, for example, by extended rough running with carburettors poorly balanced, or engine starting problems being left unresolved.

Figure 1 – transverse crack Kievprop on propeller blade

Operators – of all Kievprop propeller types – should be aware of these potential damage types when inspecting the propeller. Propeller inspection should form part of the normal pre-flight inspection.

If damage is found the aircraft should not be flown until replacement propeller blades are fitted. Owners are requested to report any damage found to the BMAA.

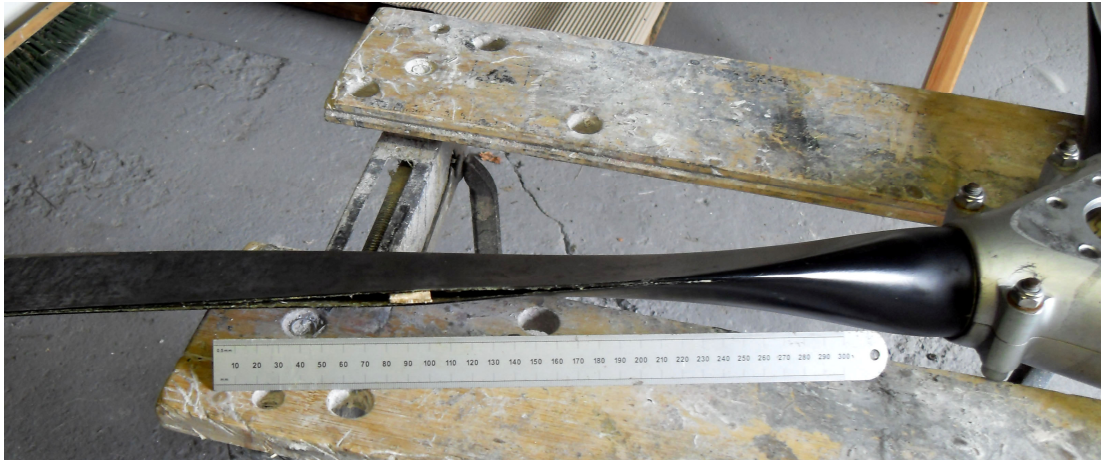
A small number of Kievprop propellers fitted to BMAA aircraft have suffered delaminated trailing edges as shown in Figure 2.

Figure 2 – delaminated trailing edge

Trailing edge cracking can occur from moisture in the (hollow) blade, especially if it freezes. The blades come with a vent hole at the tip, but this can get blocked over time.

The drain holes should be checked periodically, and cleaned out if blocked.
