**Reference:** BMAA Service Bulletin 2462 Issue 2  
**Title:** Inspection for material type – Control Cable Shackles and Elevator Joiner.  
**Applicability:** All UK Sky Ranger, Sky Ranger Swift and Sky Ranger Nynja  
**Author:** Paul Dewhurst, Flylight; Adrian Jones & Ben Syson, BMAA  
**Effective date:** 1 December 2013  
**Classification:** Mandatory

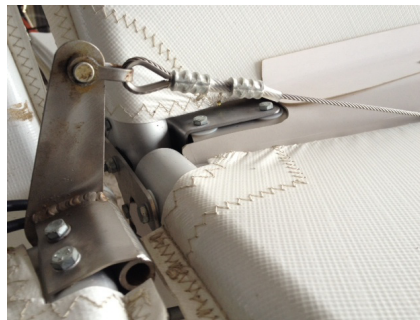
**Elevator Joiner 124**

A batch of non-optimum stainless steel alloy entered the production process for a limited time. This can result in a reduction of strength and cracking of the affected parts.

**Elevator Joiner variants**

If the Elevator Joiner is found to be cracked it must not be flown with and must be changed before the next flight.

If the Elevator Joiner is found to be of the wrong material (but not cracked) it must be inspected for cracks before every flight and replaced not later than 31 January 2014.

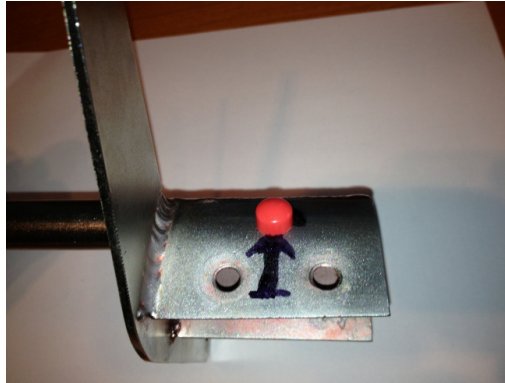
If no cracks are found, next check the joiner with the magnet. The parts to check are the welded on plates with the 6mm diameter attachment bolt holes in them. The check may be done in situ without dismantling from the aircraft. But be aware that the bolts will be magnetic, so check some distance away from them (in the position shown in the photo below).

**Test in the area indicated**

- If the magnet does not stick to the plates, then the Elevator Joiner is good.
- If the magnet sticks to the plate, then the Elevator Joiner is bad and must be replaced no later than 31 January 2014. Also, conduct a visual inspection to ensure no cracks exist before each flight. If cracks are subsequently found the Elevator Joiner must be replaced before flight.

If changing the joiner, use new split pins on the control connections, and new nyloc nuts on the securing bolts. Verify correct reassembly, control sense, deflection angles and free movement before flight.
