**Reference:** BMAA Service Bulletin 2477 issue 2  
**Title:** Shock absorber – inspection for correct manufacture  
**Applicability:** All Raj Hamsa X'Air (UK) and Raj Hamsa X'Air Falcon (UK)  
**Author:** Ben Syson, BMAA  
**Effective date:** 6 December 2013  
**Classification:** Advisory alert bulletin

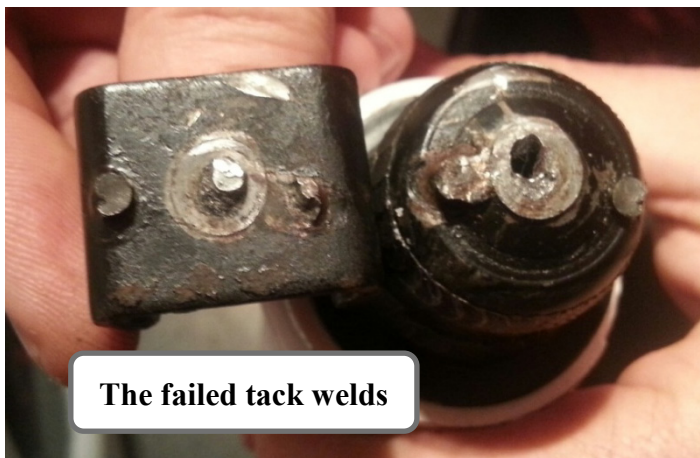
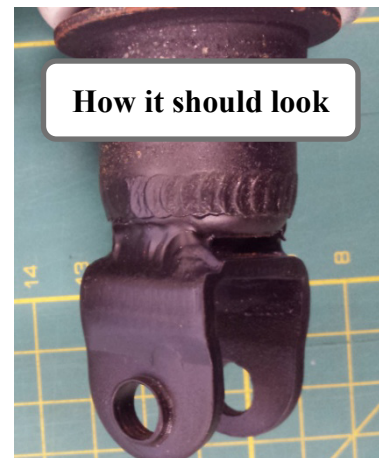
A shock absorber failed during the take-off run, resulting in a partial collapse of the undercarriage. Little other damage was done and nobody was injured. The UK importer, the Wessex Light Aeroplane Company Ltd (WLAC), has investigated the failure and found it to be a manufacturing defect. Although it is believed to be a 'one off', this cannot be guaranteed, hence this bulletin.

The shock absorber affected is the type with a separate coil spring. The shock absorber was supplied in the first half of 2012. The failure occurred at the welded junction between the main body of the shock absorber and the U-bracket at the lower end. The U-bracket was tack-welded onto the shock absorber but not finished: final, structural welds at the junction between the main body of the shock absorber and the U-bracket at the lower end were omitted.

The shock absorbers should be inspected for correct manufacture as part of the next pre-flight inspection. If the weld is missing do not fly the aircraft and contact WLAC for replacement(s). Replacements must be fitted in accordance with the appropriate Build Manual and normal BMAA procedures for part replacement. Contact your BMAA Inspector or the BMAA Technical Office for advice if at all unsure.
