**Reference:** BMAA Service Bulletin 2758 issue 1  
**Title:** Elevator control cable abrasion  
**Applicability:** All UK (BMAA) MXP-740 Savannah  
**Author:** Ben Syson, BMAA  
**Effective date:** 1 July 2019  
**Classification:** Advisory Service Bulletin

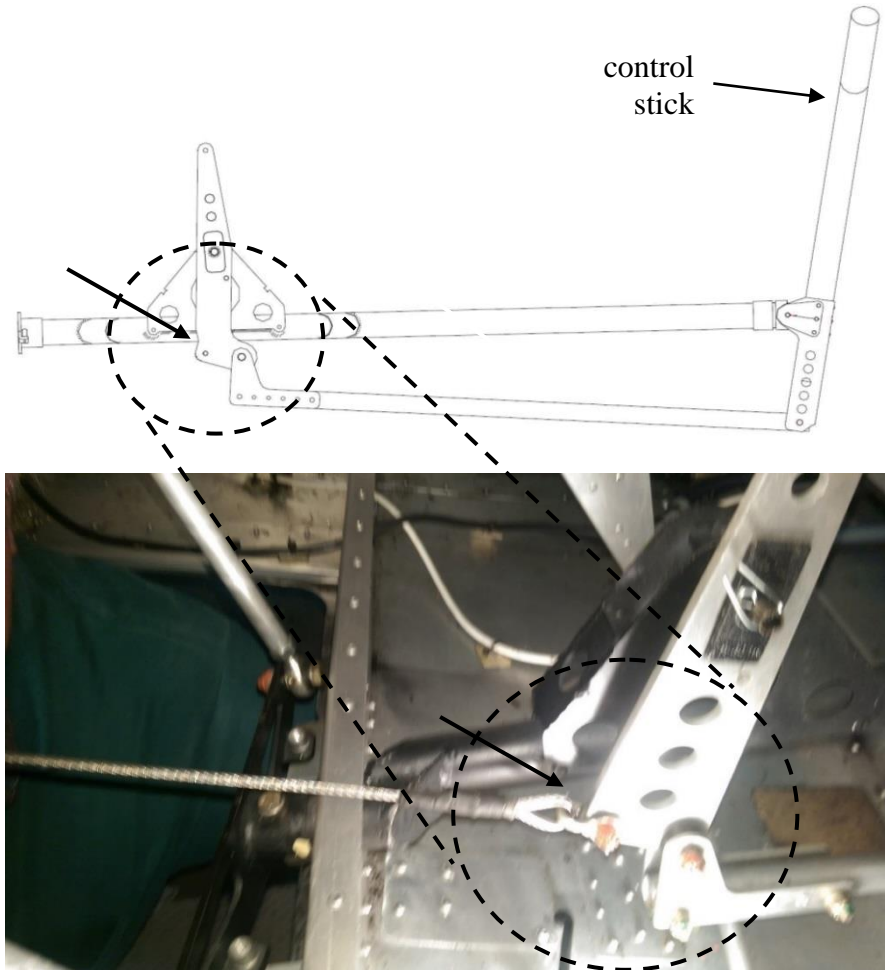
The elevator control cables are connected to the crank at their forward end using D-shackles\*. On the aircraft in question this allowed the end of the lower, 'up elevator', cable to contact the crank when the stick was held fully back. The contact point was at the end of the cable where it is formed into a loop around a thimble. Over time this caused damage to the cable as well as marking the crank. The point of connection of the cable to the crank is highlighted in the drawing and photo of the control system below. Note that the control stick is to the right-hand side in both cases (although not visible in the photo).

\* On later aircraft, each D-shackle is replaced with a pair of plates and a pair of bolts. This maintains a greater distance between the elevator cable and crank, so that contact is impossible.

The area is easily accessible through the large inspection hatch under the fuselage immediately behind the main undercarriage hoop. Good illumination – such as a bright torch – is essential. It is recommended to have an assistant to operate the controls to see if the cable comes into contact with the crank.

If there is damage to the cable or crank – such as broken strands or significant wear - the aircraft may not be flown. If there is slight contact, and no significant damage yet, the aircraft may continue to be flown while the problem is resolved subject to regular inspection of the cable and crank to ensure their condition is not deteriorating.

Report all cases of contact between cable and crank to the BMAA Technical Office ([technical.office@bmaa.org](mailto:technical.office@bmaa.org)) so that we are aware of the extent of the problem, and can advise on possible repairs (in case of damage) and approve modifications (to stop further damage).

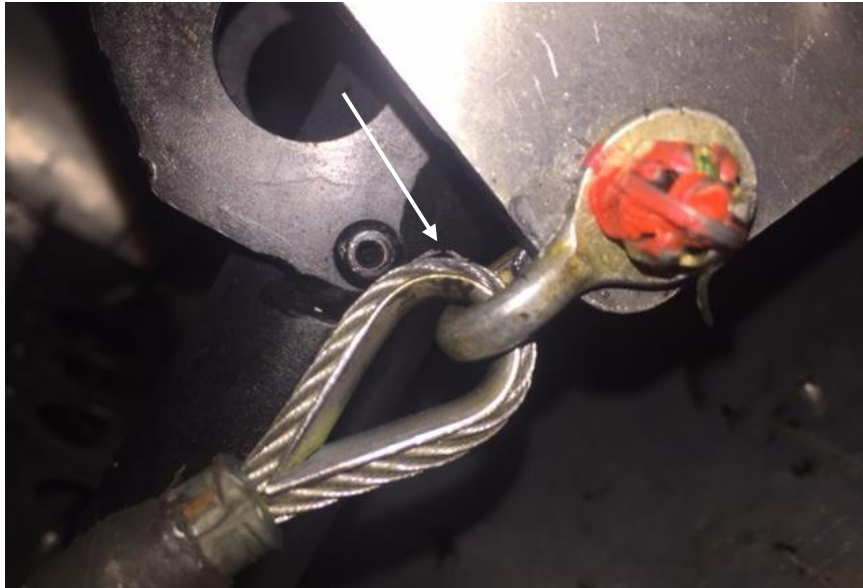
An elevator control cable was found to be coming into contact with the crank at its forward end, resulting in a broken strand of wire. Another example of the same issue has been reported, although the contact had not yet caused significant damage to the cable in this case. This bulletin is issued to advise all other owners and their BMAA Inspectors of this potential problem.

The photo below shows the broken strand in the cable.
