Reference: BMAA Service Bulletin 2759 issue 1
Title: Upper port engine mounting bolt failure
Applicability: All UK (BMAA) Sky Ranger aircraft with Rotax 912-series engine
Author: Ben Syson, BMAA
Effective date: 1 July 2019
Classification: Advisory Service Bulletin

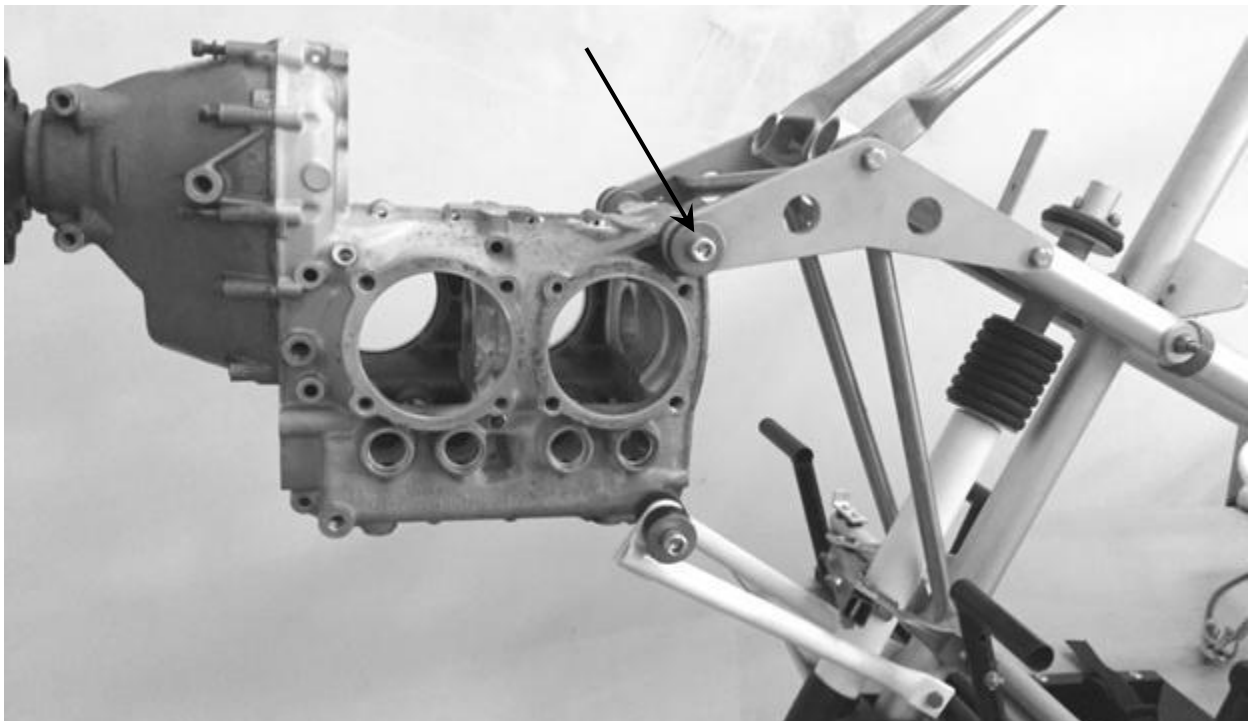
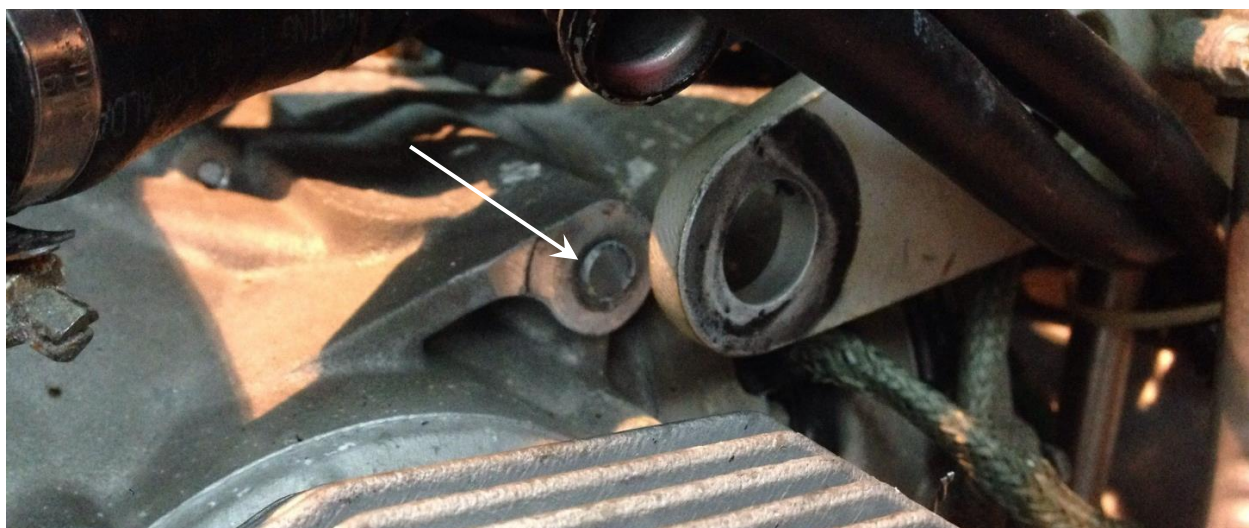
There have been three reported failures of the upper port (left) engine mounting bolt on UK Sky Rangers. (There have also been multiple occurrences abroad, although the foreign design standard is not necessarily identical). The bolt in question is highlighted in the photos below; the bottom photo shows a failed bolt. This bulletin is issued to advise owners and BMAA Inspectors of this potential problem, and how to minimise the risk of its occurrence.

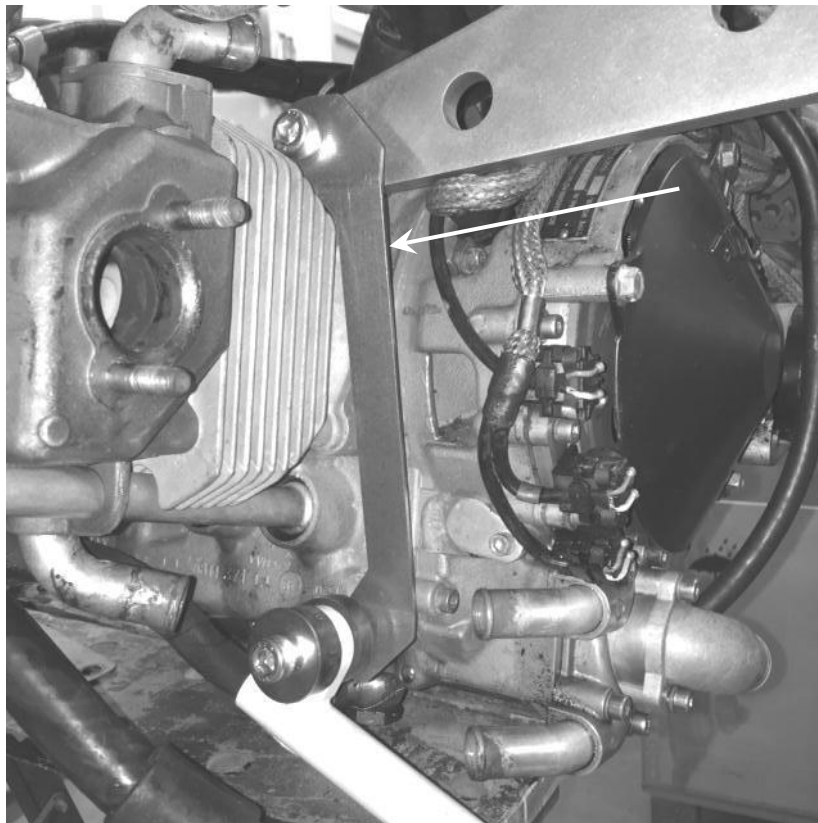
A bracing strap is available as an option which is intended to support the outside of the upper port mounting bolt to eliminate, or at least reduce, the bending loads that this bolt is subjected to. At the time of writing no failures of the upper port mounting bolt have been reported, but this modification does not yet have sufficient service experience to prove that it eliminates the problem.

The latest Build Manuals incorporate the bracing strap on Rotax 912ULS engine installations, which give the bolt a harder time than the Rotax 912UL engine. For existing Rotax 912ULS engined Sky Rangers that were built before this option was devised, it is recommended to fit the bracing strap at a suitable juncture such as the next major engine service. Use new anti-vibration mounts and mounting bolts. Build Manuals are available on the Sky Ranger website (www.skyranger.co.uk).
