## MICROLIGHT AIRWORTHINESS APPROVAL NOTE

MAAN NO: 2996

TITLE: Microlight Airworthiness Approval Note 2996: Compulsory Service Bulletin reference cracks in the extruded bars of the main wing spar attachments

APPLICABILITY: UK (BMAA) MXP-740 Savannah aircraft, specifically: G-CCII (BMAA/HB/285)

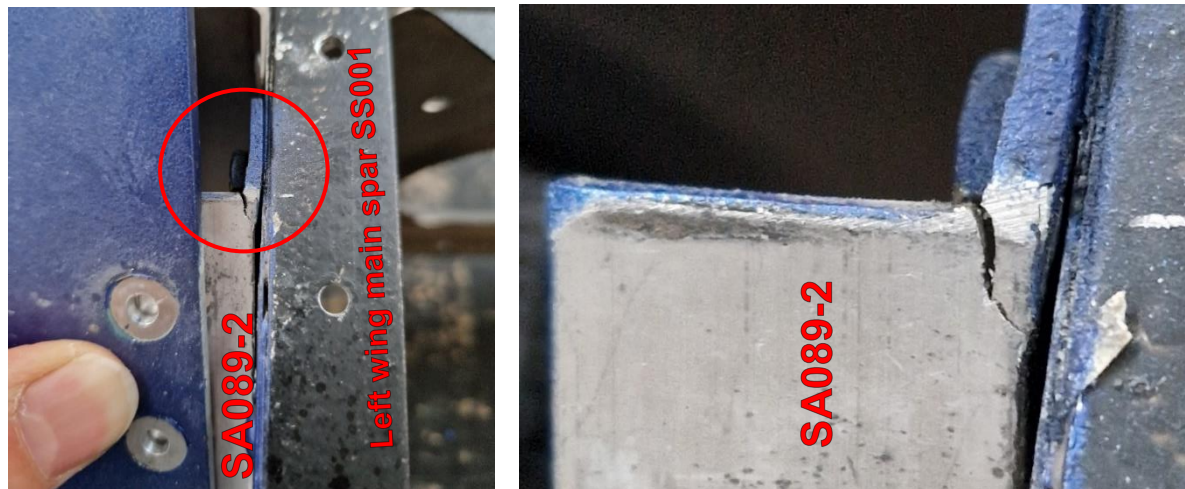
*Figure 1: Left front strut attachment to the spar*

Replacement of the extruded bars of the main wing spar attachments: SA089-2 and SA090-2. See *Figure 1* and *Figure 2*.

On the *Savannah VG* aircraft, it has been discovered a crack on the subject parts, during a reparation of the wing.
