Reference: BMAA Service Bulletin 2641 issue 1
Title: Savannah Lower Nose-Leg-Support-Bracket Cracking
Applicability: All BMAA Savannah aircraft
Author: Ben Syson, BMAA
Effective date: 1 February 2017
Classification: Advisory Service Bulletin

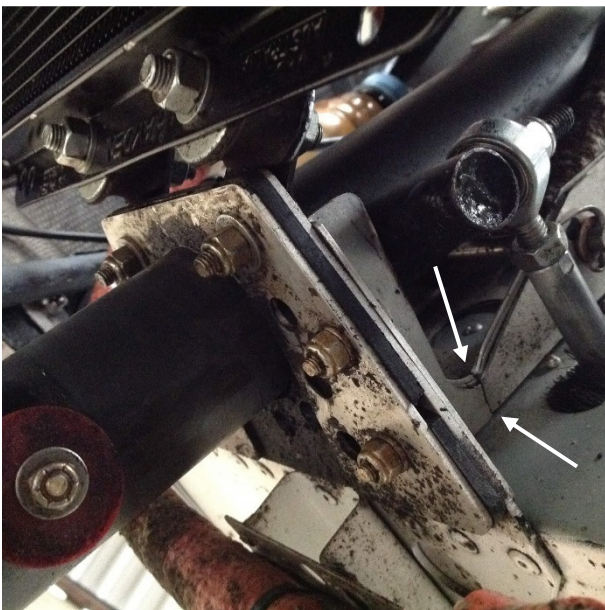
A small number of examples of cracking of the lower nose leg support bracket on BMAA Savannah aircraft have been reported. See figures 2.1 and 2.2. If left unrepaired such cracking could lead to more extensive damage and/or collapse of the nose leg.

Figure 2.1: cracked support bracket viewed from below (port side of nose leg)

The area is relatively straightforward to inspect. It is recommended that it is checked as part of the Daily inspection, with a detailed inspection every 50 hours or annually, whichever comes first.

If the bracket is damaged it must be replaced. A replacement 'box' bracket is available from the UK importer, Sandtoft Ultralight Partnership (SUP), which is stiffer and less likely to suffer from fatigue cracking in future. See figure 3.1. Note that this 'box' bracket is supplied as standard with new aircraft kits.

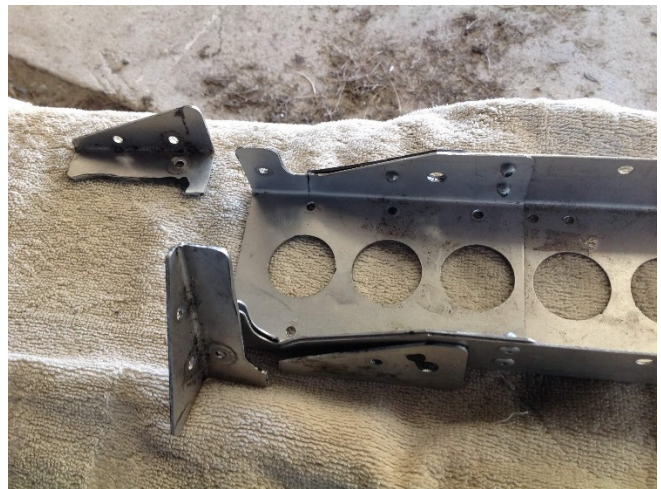
Figure 2.2: cracked bracket after having been removed from aeroplane

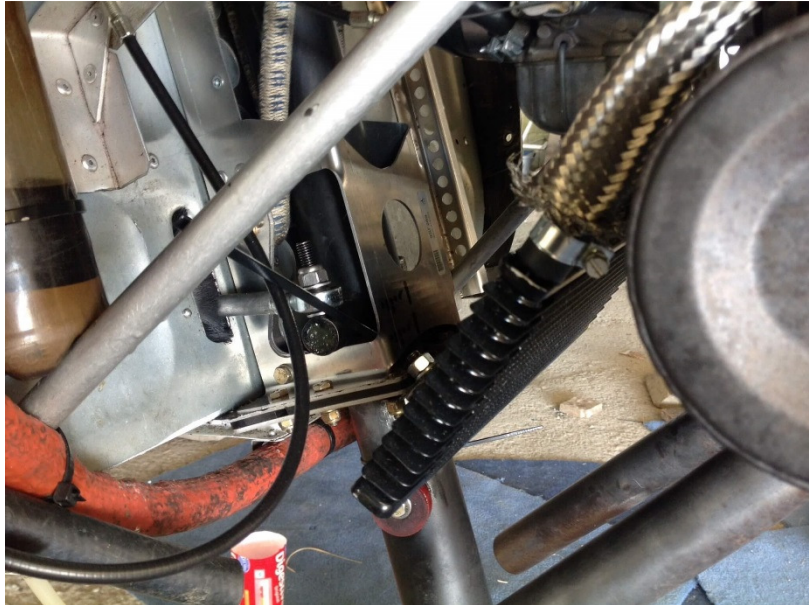
Figure 3.1: new 'box' bracket installed viewed from starboard side of nose leg
