# BRITISH MICROLIGHT AIRCRAFT ASSOCIATION SERVICE BULLETIN

**Reference:** BMAA Service Bulletin 2624 issue 1  
**Title:** Savannah Pitch Control and Trim Systems Configuration  
**Applicability:** All UK Savannah MXP-740 aircraft (except G-CCII, S/N BMAA/HB/285)  
**Author:** Ben Syson, BMAA  
**Effective date:** 13 February 2018  
**Classification:** Essential Service Bulletin

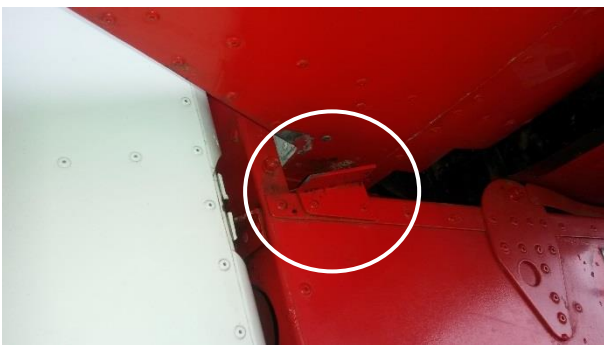
Figure 3.1 - elevator 'down' stop

- The elevator 'down' stop is provided by an angle bracket riveted to the fuselage beneath the elevator. See figure 3.1.
- The elevator 'up' stop is provided by a cut-out in the base of the fin. See figure 3.2.

Note: on the ground, the elevator must sit on the ‘down’ stop, and it must easily reach the ‘up’ stop using the control stick.

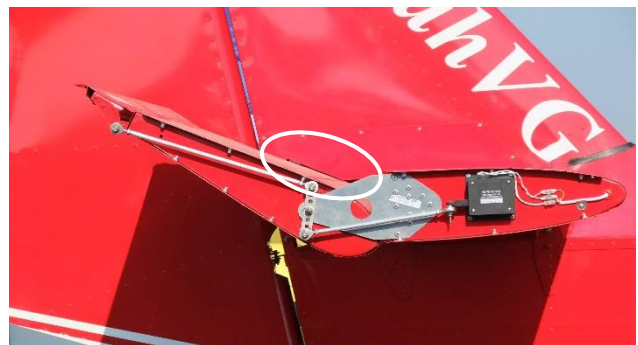
Figure 3.2 - elevator 'up' stop

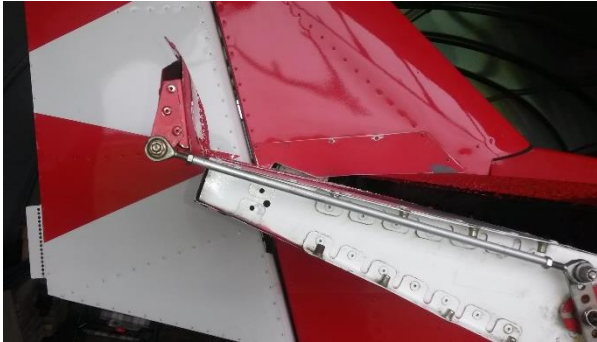
The electric trim system uses a larger trim tab horn than the original bungee trim system. It is essential that only this large horn is used with the electric trim system. If the original, smaller horn is used with the electric trim system, the trim tab moves too much, which strains, and can break, the trim tab control system. Figure 6.1 shows the trim tab going 'over-centre' as the elevator approaches its maximum upward travel.

**Figure 6.1 - incorrect (small) horn from obsolete bungee trim system**

Item	Description	Initials BMAA Inspector
1	Confirm that correct 'large' horns installed on trim tab end ribs. Refer to Figures 6.1 and 6.2. Ensure that trim tab horns, trim tab end ribs, and trim tab are all in satisfactory condition and securely riveted together.	
2	Confirm that pitch control system set up as per Sections 3 and 4, ensuring that elevator deflections limited by stops at tail (not by control system parts coming into contact at front of aircraft). On ground, elevator must sit on 'down' stop, and easily reach 'up' stop using control stick.	
3	Confirm that elevator control cables correctly tensioned as described in Appendix 1.	
4	Ensure that complete elevator control system - from stick rearward to elevator - operates 'full and free' (without parts binding or cables rubbing).	
5	Measure elevator deflections from neutral as described in Section 3:  Up: _____ °  Down: _____ °  The deflections were measured using a <b>protractor / inclinometer</b> (delete as applicable).

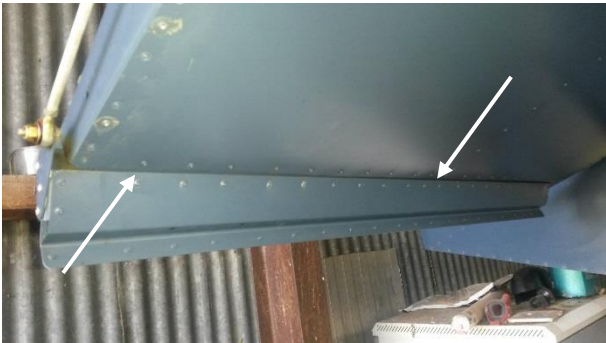
**Figure 8.1: positive clearance between trim tab and elevator**

1. With full nose-up trim set (trim tab biased down), and full forward stick (elevator down), confirm that there is positive clearance between the trim tab and elevator. See figure 8.1.
2. With full nose-down trim set (trim tab biased up), and full back stick (elevator up), confirm that the trim tab is in no danger of going 'over-centre'. See figure 8.2.

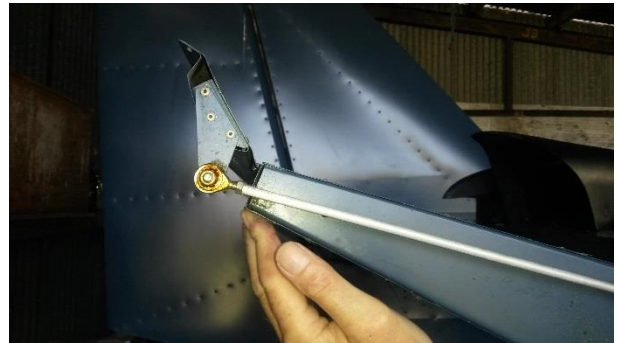
**Figure 8.2: trim tab in no danger of going 'over-centre' (compare with fig 6.1)**
