TO ALL AREA AND LOCAL INSPECTORS AND CLUB SAFETY OFFICERS

NOTIFICATION OF A CAA AIRWORTHINESS DIRECTIVE

CAA AIRWORTHINESS DIRECTIVE 001-10-88

SUBJECT - DESCRIPTION Propeller - Replacement of Attachment Bolts

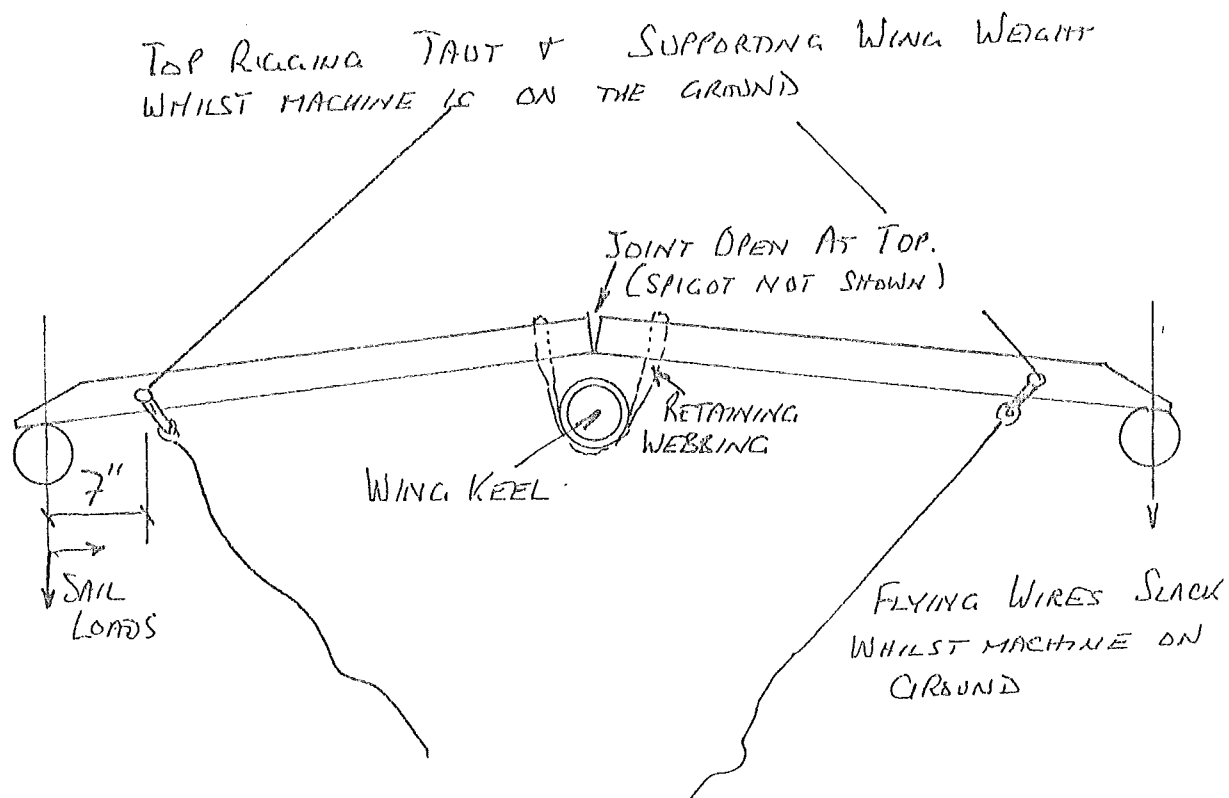
FIGURE 1

When the aircraft is stationary, the two wings hang on the top rigging supported by the king-post. The 12 ft wires stretch slightly and - in addition - the design is such that slack is purposely built into the lower flying wires to aid handling in the air. This gives the position shown in Figure 1. The sail tension causes a compressive load and, because the strain line passes through the bottom edge at the centre-point and the bottom edge at the leading edges, the cross-tube will bow upwards slightly, at the centre.

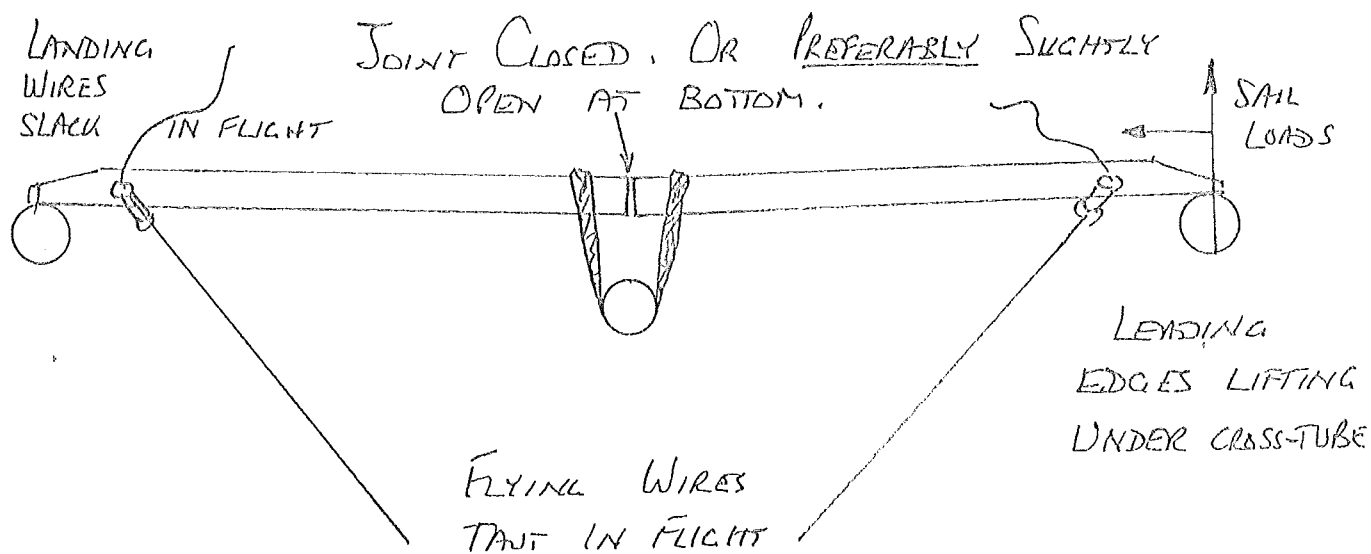
FIGURE 2

Under flight loads, we now consider Figure 2. The centre joint is closed, (preferably open at the bottom), the flying wires limit the upward movement and the cantilever loading reacts against the flying wires. This counteracts the upward 'bow'. The centre joint puts the contact square-on (or preferably at the top of the tube) and the leading edges push upwards against the cantilevered wire-anchorage. The 'bow' seen on the ground disappears in the air.
