**BMAA Defect Alert #0069: Rotax 912 Series - Inspection and/or replacement of the valve push-rod assembly**

**Applicability:** Rotax 912UL, 912ULS, 914UL & 912 iS Sport

# Inspection and/or replacement of the valve push-rod assy., rocker arm left and rocker arm right for ROTAX® Engine Type 912 i, 912 and 914 (Series)

ATA System: 72-30-00 Cylinder head

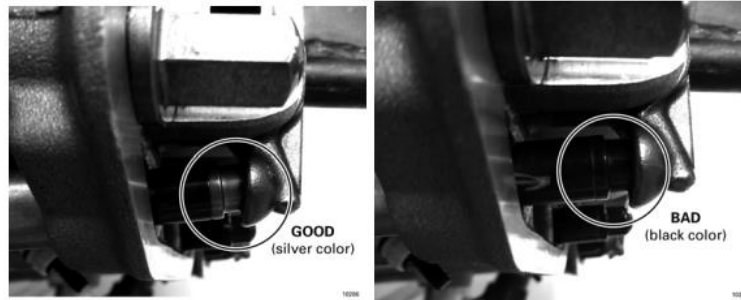
Essentially there are two different types of push-rod, a diagram of the push-rods can be found in Appendix 4 of the bulletin:

comparison of spare parts:

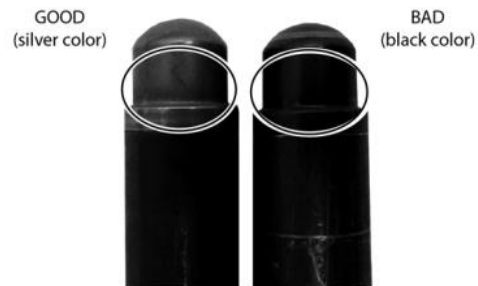
Fig. 1  
Visual inspection

Check for color. See Fig. 1.

### 3.1.3) Replacement of affected parts on affected cylinder positions (only in case visual inspection is NOT passed OK)
