BMAA TECHNICAL INFORMATION LEAFLET (TIL) STANDARD MINOR MODIFICATION **SMM 118 – ADS-B OUT** (CONNECTION OF GPS TO MODE S TRANSPONDER) **ISSUE – 2** **APR 2021**

APPENDIX A – GROUND TESTING

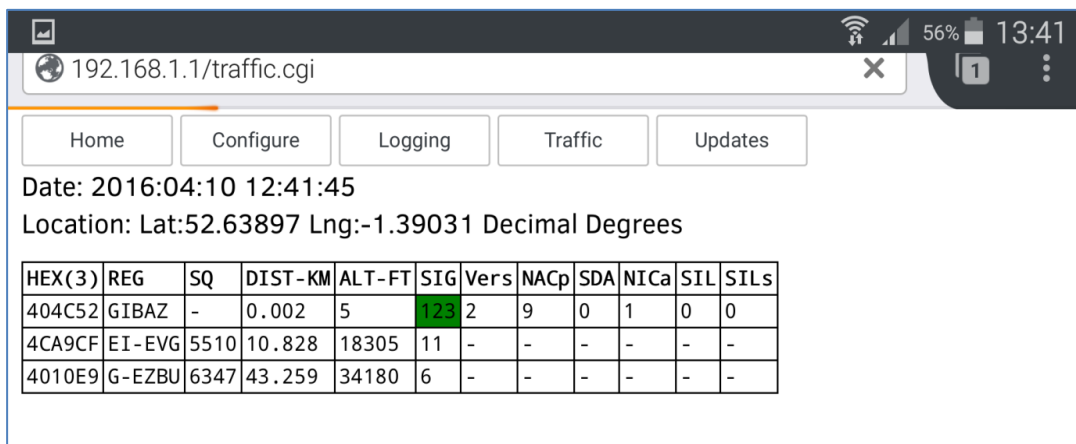
Early PilotAware Screen Shown:

Using the computer linked to the PilotAware unit, use a web browser to navigate to the PilotAware data screen (URL: 192.168.1.1). Select the 'traffic' screen, which should show a screen similar to either of the following:

- Check that the date, time and position are correct.
- Check that the aircraft being checked is listed (probably at the top) and that it shows the correct Mode S 'hex' code (which can be checked on the CAA's G-INFO database), registration and squawk code and distance. The 'SDA' and 'SIL' fields should show '0' for non-certified and '1' for certified GPS source.

Take a screen print. On Google Chrome for tablets, this can be done by selecting 'print' from the drop-down menu and then saving as a PDF. Otherwise, a photo of the screen can be taken. A copy of the screen shot should be included with the submission, making sure that it is clearly legible.

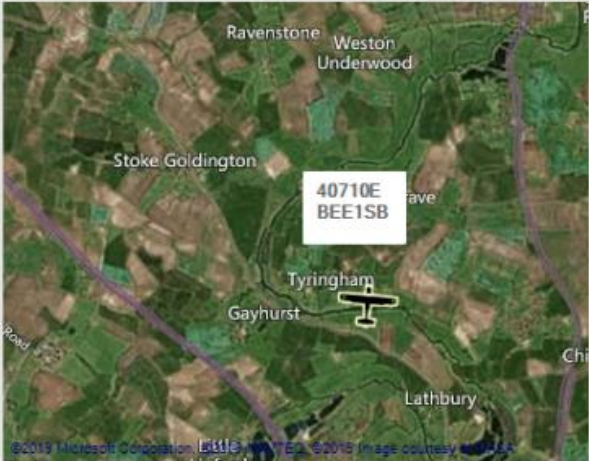
Map

Ensure that the aircraft is chocked and in a safe area with an appropriate person at the controls. With the engine running and all electrical services switched on (e.g. strobes, lights, avionics, etc), ensure that the source GPS and transponder are on and transmitting. The software on the computer should show a screen similar to below:

ICAO	40710E	SILs	0	NACp	10
Call Sign	BEE1SB	VERS	2	HRD	0 True North
Altitude	16,000ft Q: 1 (25ft Resolution)	NIC	8		
Squawk	7630	Rc	< 0.1 NM (185 m)		
NICsb	0	FS	0 no alert / no SPI - airborne		
NICa	0	Country	United Kingdom		
SDA	2 Major	Speed	280		
SIL	3	Heading	4		
Lat Lon	52.12129,-0.75394	VSI	+4 (Baro)		
Emitter Category	2 Small (15,500 to 75,000 lbs.)				
Surveillance Status	0 No condition information				
CA	DF11 -> Level 2+3+4 (DF0,4,5,11,20,21,24,code7 - is airborne)				
Recorded:	03 October 2019 - 12:00:02		Total Messages: 707

- Check that the date, time and position are correct.
- Select the aircraft being checked and check that it shows the correct Mode S 'hex' code (labelled 'ICAO' - this can be checked on the CAA's G-INFO database), registration and squawk code. The 'SDA' and 'SIL' fields should show '0' for non-certified and '1' for certified GPS source.
